Reconstruction of the Grenfell Tower Fire—Thermomechanical Analysis of Window Failure During the Grenfell Tower Disaster

Abstract. Observations and numerical studies have allowed an understanding the fire development inside apartments and over the façade during the Grenfell Tower fire. During these analyses, the highlighted need was for a deeper investigation into the failure of windows during the fire. This detailed and complex model for window failure validates the thermal breakage criteria used in fire simulations of the whole Grenfell Tower fire. However, the present investigation is dedicated to a single pathway for the influx of fire and toxic smoke. Other pathways from the façade to the apartments, such as the melting of elements surrounding the window frame, are not addressed here. To analyse window behaviour during fire, Finite Element Method thermomechanical modelling is used. First, a heat transfer analysis is performed for windows subjected to the external flames from the identified façade fire scenario. The thermal loads evaluated from the fire are applied to the window structures to estimate their failure times. Two window casement configurations, closed and tilted-i

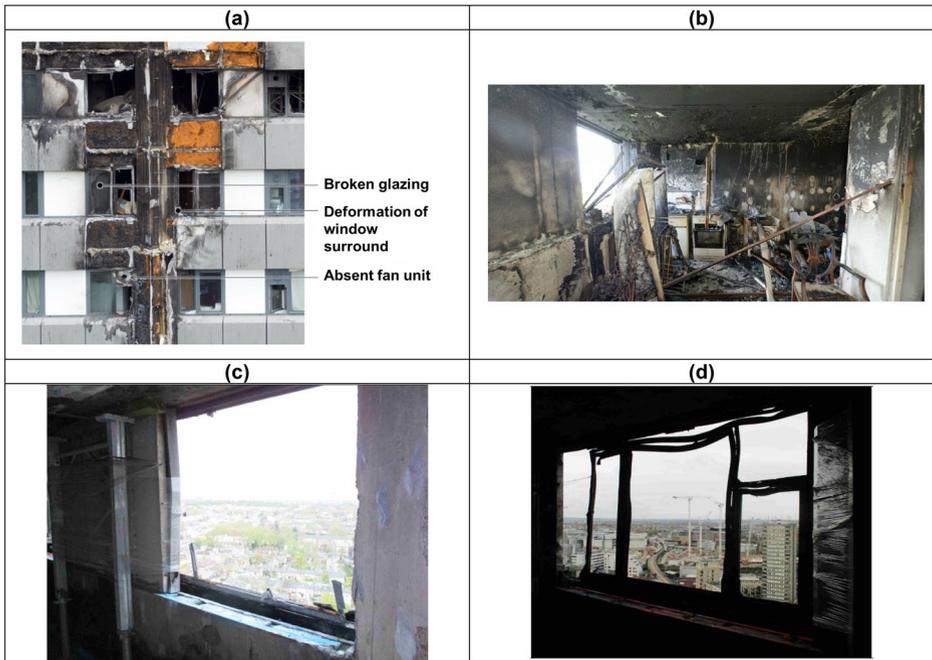
Post-fire observations have shown different failure modes for the windows: inward fallout, outward fallout and partial failure exist at several locations on the Tower. Examples of inward and outward fallout of windows are visible in Fig. 3. However, all the failure modes are quite binary since we observe either a window still in place or no more window.

The failure of the window can also be due, at first, to the softening and/or melting of the uPVC reveal liner, between the window and the concrete structure, when exposed to heat from the external cladding fire, or to thermally induced breakage of the window glazing. Thus, window fallout was probably not the only way of flame exit and re-entry during the Grenfell disaster. However, the failure

Figure 3. a Failure mode of window frame, L. Bisby's expert report [30], Fig. 11, p. 166, b Inward failure of window frame, J. Torero's expert report [32], Fig. 54, p. 91, c Outward failure of window frame, B. Lane's expert report, Appendix C [31], Table 11C, p. 94, d Partial failure of window frame, B. Lane's expert report, Appendix C [31], Table 11C, p. 95.

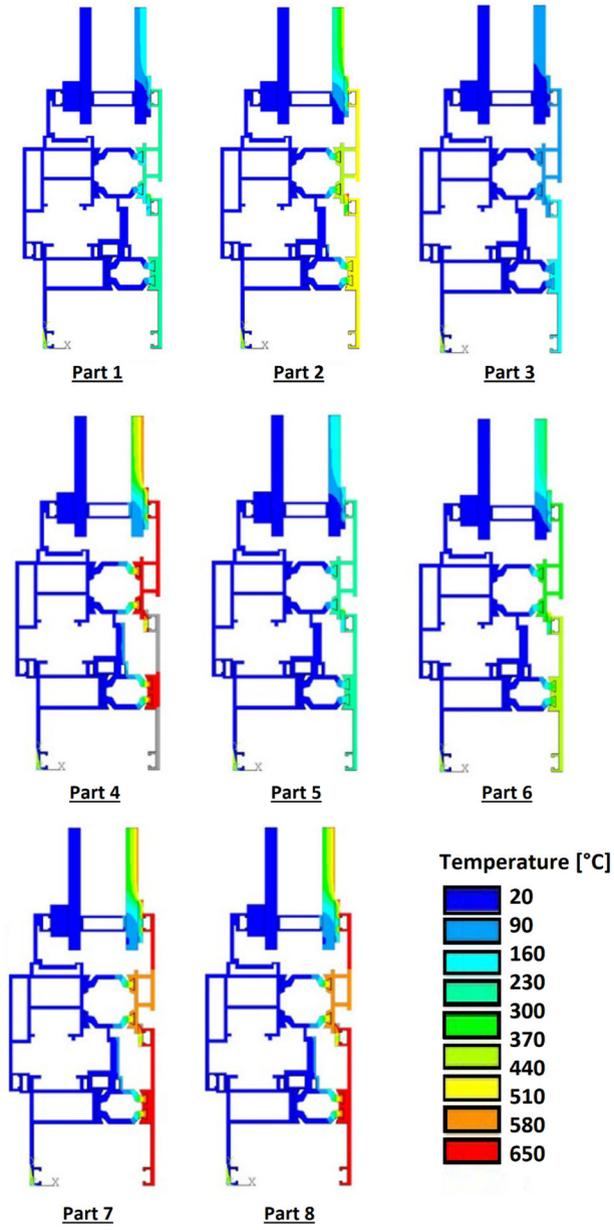
The thermal fields at all sides of the window frame at 180 s (3 min) of fire exposure are addressed in Fig. 13. The temperature is at about the melting point ($650 \text{ }^\circ\text{C}$) at the exposed side of Parts 4, 7 and 8. The results show also that the

exposed side of the window has been melted at all parts except Part 3 before about 4 min.

◀ **Figure 13. Temperature fields for different locations in the window frame at 180 s of fire exposure.**

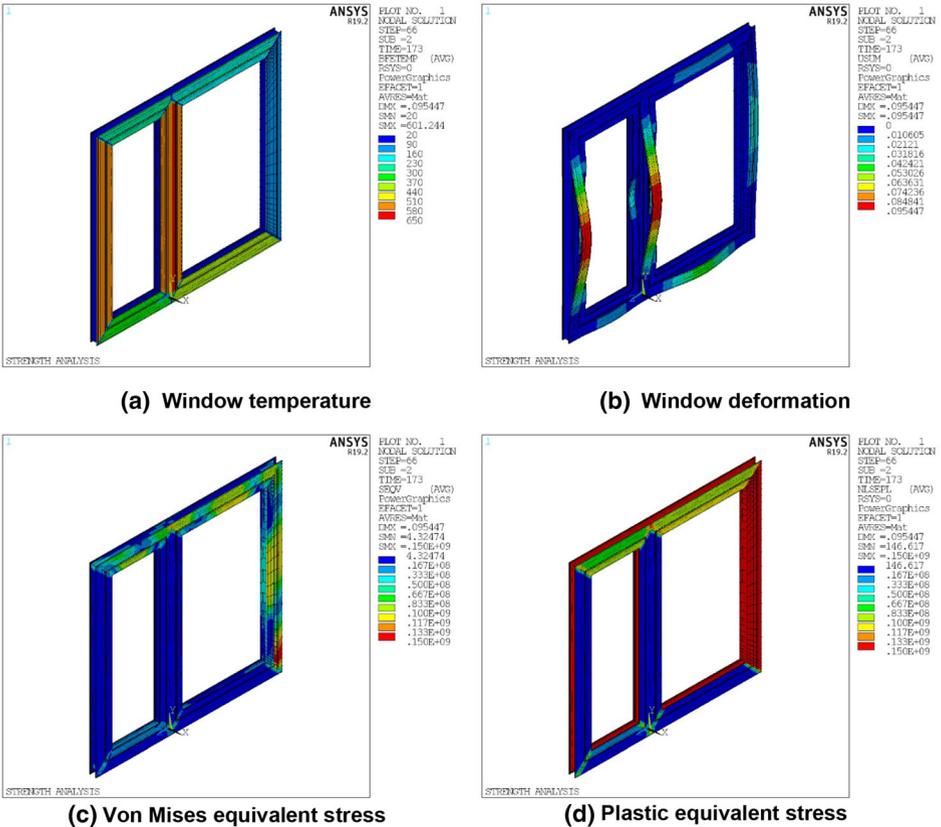
Figure 18. Frame temperature (a), deformation (b), Von Mises stress (c) and plastic equivalent stress (d) before the failure of the outer frame at 173 s of fire exposure for the closed window configuration.

Figure 18a gives the temperature of different Parts of window. These temperatures are computed by 2D thermal analysis. The temperature is almost uniform through the Aluminium thickness. The temperature fields are mapped from the 2D thermal model to the 3D mechanical model in 56 layers through the cross sections for each Part of the window. The temperature on the left side of the frame is indeed lower than the one on the middle component. This is due to the presence of the column located nearby the left part of the window. The vertical flames venting out the lower flat window are impinging the façade above but are deviated by the column having a triangular shape. The flames reattached to the column, leading to lower temperature on the left side of the window that can be considered “shaded” while the flame attached along the column. Convective effects are thus enhanced at this location. The vertical outer profiles of the frame are deformed and may be detached from the rest of the structure because of the large deflections as shown in Fig. 18b. The left side of the exposed frame plasticised because of the thermal stress (Fig. 18c). Aluminium alloy’s yield stress decreases at high temperature. The material resistance is totally removed at the bottom and left side of the window (Fig. 18d). At this moment, the outer profile of the frame detaches from the rest of the window and falls outward. The dynamic force due to the weight of the outer profile and casement may lead to its outward failure.

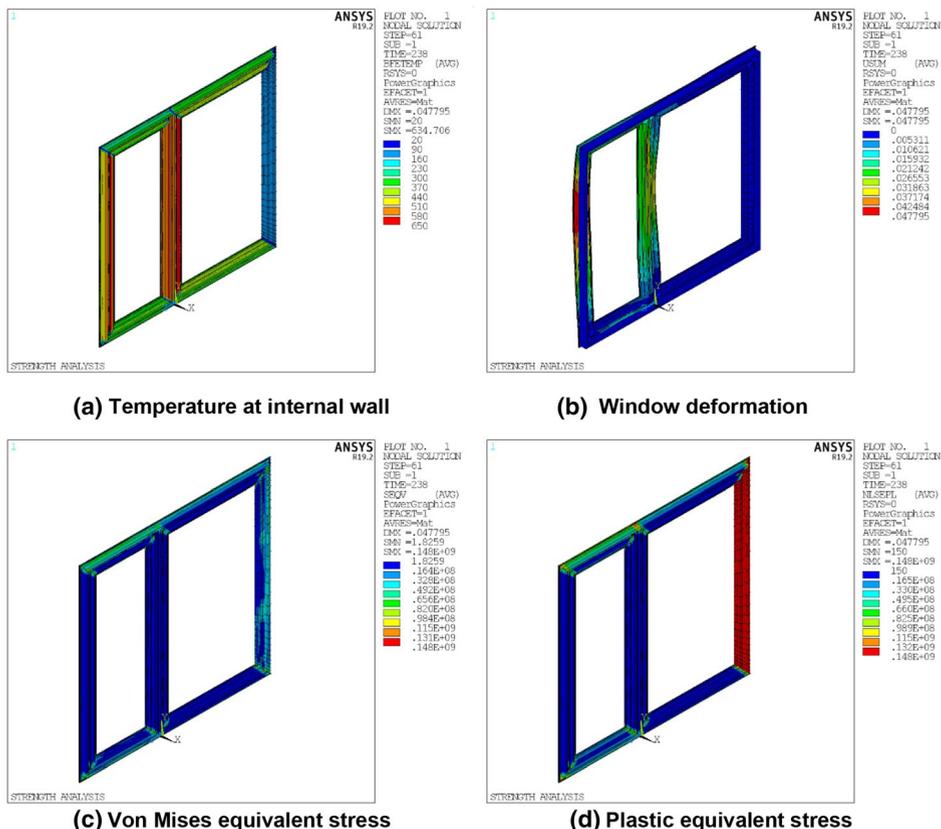
If the external profile of the window collapses without pulling the whole window out, the inner profile will fail inward. The modelling results show the collapse of the inner profile of the frame at about 4 min (238 s) of fire exposure. Figure 19 refers to the temperature, deformed shape, Von Mises stress and plastic equivalent stress for the window before the collapse of the inner profile. The modelling yields a maximum internal profile temperature of up to 600 °C when the failure occurs for the external profile. At this time, almost all of the left side of the structure plasticised, which leads the window collapse.

Figure 19. Frame temperature (a), deformation (b), Von Mises stress (c) and plastic equivalent stress (d) before the failure of the inner frame at 238 s of fire exposure for the closed window configuration.

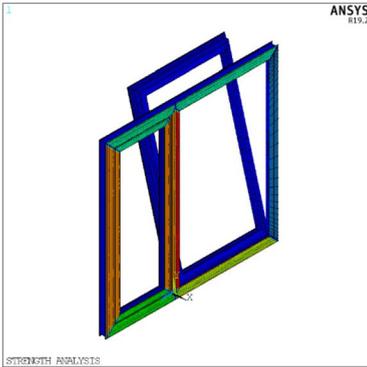
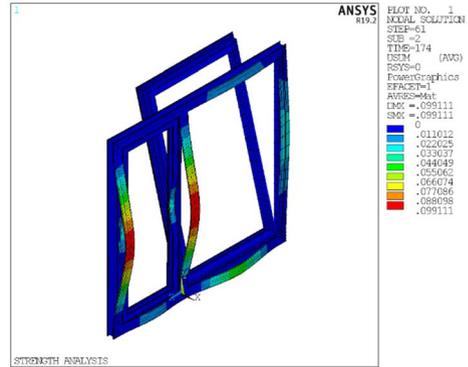
Temperature loads are applied to all Parts of the window except the tilted casement. The outer profile detaches from the rest of the window and falls outward after approximately 3 min (174 s) of fire exposure. The failure mode of the outer profile of the tilted-in configuration is the same as that of the closed window configuration. The maximum temperature at failure time is about 610 °C on the central vertical frame Parts (Parts 4 & 7). Figure 20 shows that the vertical frame Parts are deformed and may be detached from the rest of the structure because of the large deflections. The left side of the exposed frame plasticised because of the thermal stress. However, the failure of the outer profile of the window does not cause the failure toward outside because the weight of the tilted-in casement stabi-

Figure 20. Frame temperature (a) and deformation (b) before failure of outer frame at 174 s of fire exposure for the in-tilt window configuration.

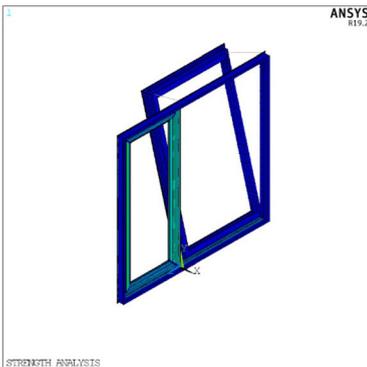
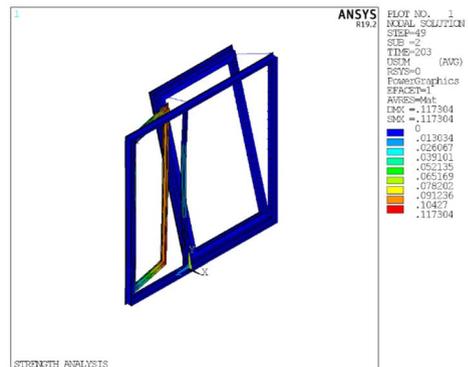
The inner profile will collapse inwards. Modelling shows that the window is deformed and the side-hung casement opens toward inside at about 3.5 min (203 s) of fire exposure. The opening of the side-hung casement, shown in Fig. 21, may generate additional dynamic force on the window and create the complete failure of the structure at this moment. This scenario may occur because the internal frame cannot resist horizontal loads after removing the external profile. However, the numerical model no longer converges at this point, because of large deformation and numerical instability of the finite element solution.

The hypothesis of collapse due to the opening of the side-hung casement may be rejected, because the temperature field evaluated for the internal profile at this

Figure 21. Frame temperature (a) and deformation (b) before failure of outer frame at 203 s of fire exposure for the tilted-in window configuration.

moment is not too high (about 270 °C) and the aluminium will still resist the loads. In that case, the complete collapse of the window occurs at the melting point of the window frame, at about 4 min.

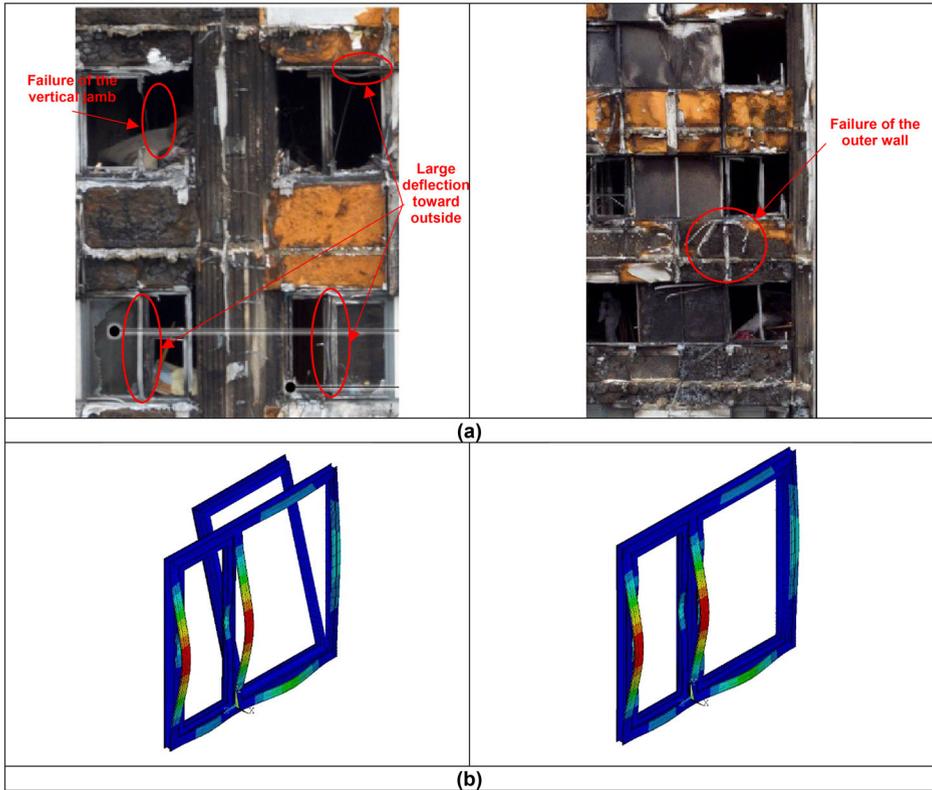
Figure 22. (a) Failure of window frame with outward fallout of the external frame of windows, L. Bisby’s expert report [30], Fig. 109 and 110, p. 166, (b) outward failure of window frame evaluated numerically for two opening configurations.

The numerically modelled thermomechanical deformation of the window frames are compared with observations after the real fire in Fig. 22. Partial failures of windows are visible, with the external part of the frame detached from the window and falling outward. Large deflections of vertical or horizontal Parts of the frame occurred during the Grenfell Tower disaster. The numerical model yields the same behaviour, whatever the opening configuration of the window.
