Sun, D., Wharton, JA., & Wood, RJK. (2011). Micro- and Nano-scale Tribo-Corrosion of Cast CoCrMo. *Tribology Letters*, 41, 525-533.

# Micro- and Nano-scale Tribo-Corrosion of Cast CoCrMo

D. Sun · J. A. Wharton · R. J. K. Wood

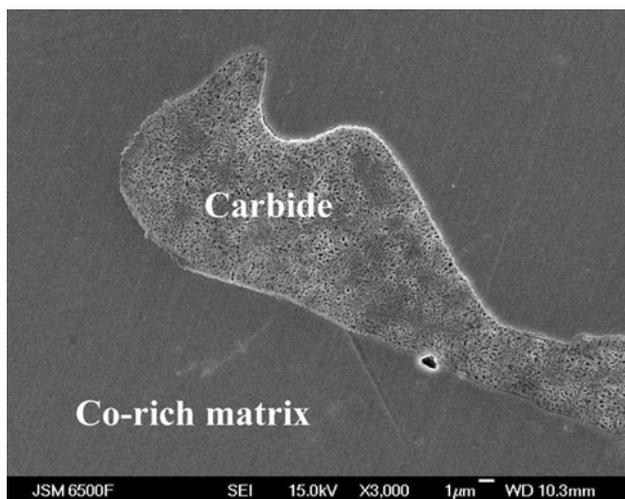
**Fig. 1** SEM image of cast CoCrMo surface and microstructure

found elsewhere [10]. Figure 1 shows a typical SEM image of a cast CoCrMo surface, where carbide blocks stand proud of the surface and have a different microstructure from the Co-rich matrix. The carbides are about 200 nm higher than the surrounding Co-rich matrix and are typically 25  $\mu\text{m}$  in size. The average Vickers hardness value of the cast CoCrMo specimen was about 4 GPa under 10 kg (98 N) weight.

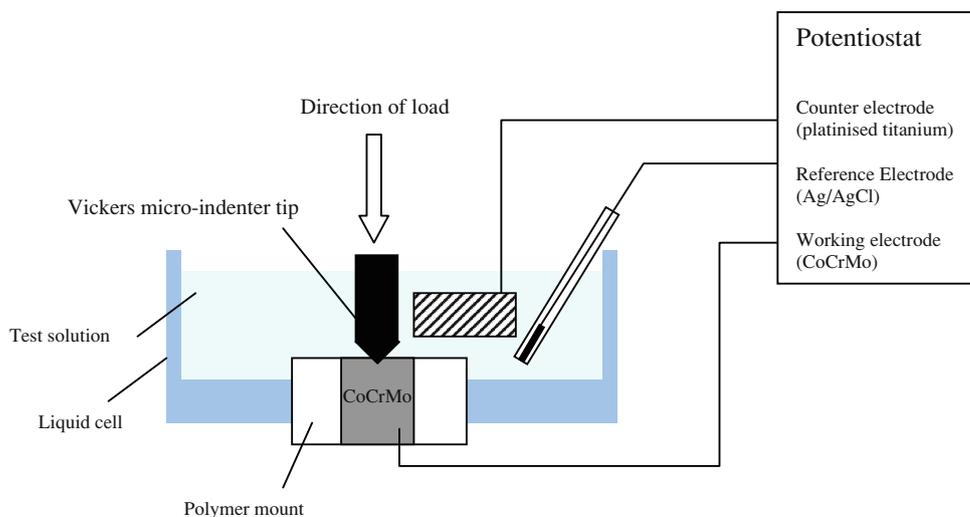
A Vickers micro-hardness indenter was used, which was fitted with a wet-cell in order to simulate the immersed condition as in the in vivo environment. A three-electrode electrochemical cell was also fitted into the wet cell to allow in situ electrochemical current noise measurements, see Fig. 2.

**Fig. 2** Set-up for wet-cell micro-indentation

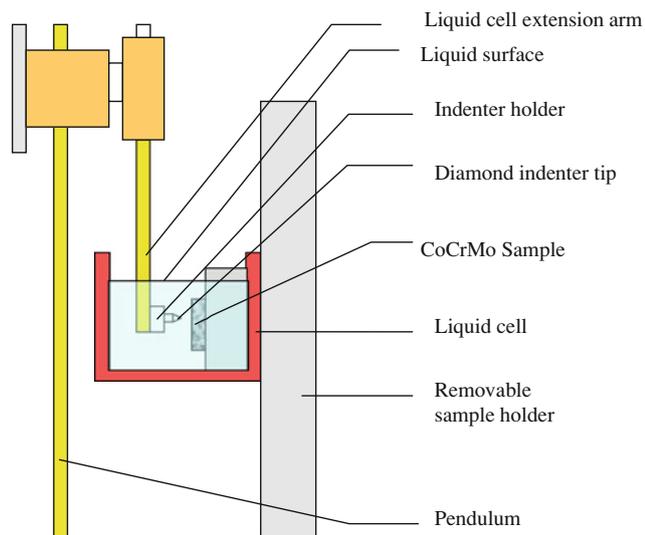
The wet-cell nano-scratch test was carried out by the nanoindenter (NanoTest platform, MicroMaterials Ltd, UK), see Fig. 3. A three-electrode electrochemical cell has been incorporated in the wet-cell. A conical diamond indenter (10  $\mu\text{m}$  tip radius) was used for the scratching tests.

**Fig. 3** Set-up for wet-cell nano-scratching

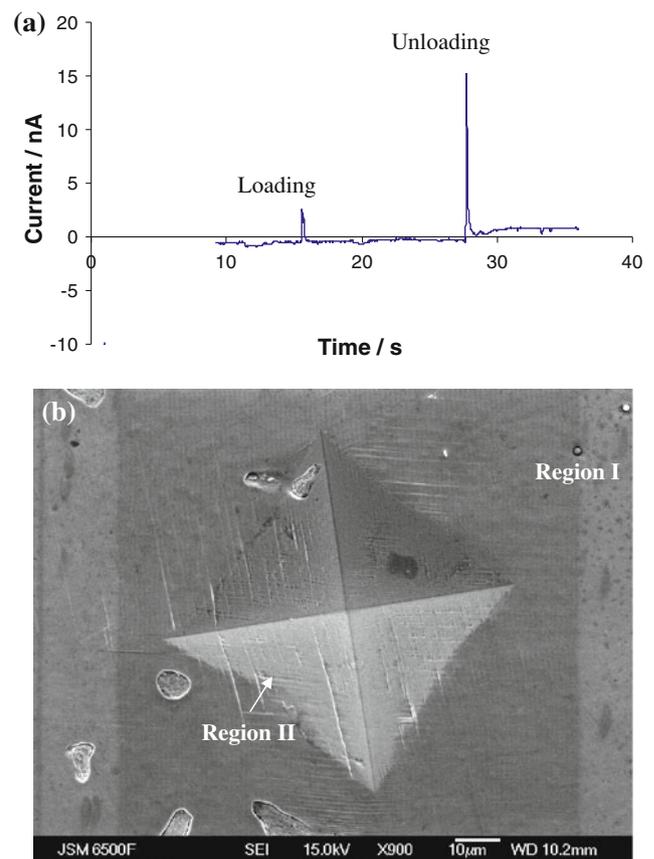
Single and multiple ( $\times 5$ ) indents were performed in 0.9% NaCl and/or 25% BS in a fully immersed condition. Figure 4a shows the loading and unloading current transient for a single indentation test made in 0.9% NaCl (applied load of 9.8 N). At the initial period of the current measurement (the first 10 s), the current rapidly reaches a limited steady-state (approx.  $-1$  nA) immediately after the closed-circuit was established within the electrochemical cell. This response is due to the  $-130$  mV applied potential under potentiostatic mode perturbing the surface—reacting to the sudden change from OCP to potentiostatic control. Overall, the background current is low (approx.  $-1$  nA), this is a response of the true sample potential being similar but not identical to  $OCP_{30\text{min}}$ . When the indenter comes into contact with the specimen surface and is driven

**Fig. 4** **a** In situ electrochemical current noise of Vickers micro-indentation made in 0.9% NaCl under 9.8 N applied load and **b** SEM image of a microindent

downwards, a small anodic peak ( $< 5$  nA) is detected which corresponds to the passive film rupturing. The current returns to the pre-indentation level while the indenter remained in the loaded position. During unloading (indenter moves away from the deformed surface), an intense current peak occurs (approx. 20 nA). The larger current peak which was produced during unloading is likely to be caused by exposure of the deformed metal/oxide surface (which is previously masked by the indenter during loading) to the electrolyte solution. The anodic current flow during this process is partly due to the metal dissolution (metal-ion release) and partly contributed to the passive film formation. Figure 4b shows the SEM image of a typical microindent where it can be seen that slip lines emerged as a result of the local plastic deformation. The interactions of dislocations and the resulted high-defect density could lead to a greater dissolution activity of the alloy.

formation (see Fig. 4b), the total affected area due to the tribological process is greater than the actual indent area. The plastic deformation process may be accompanied by local SIT [15], at the same time the sub-surface bare alloy is exposed to the external corrosive environment. The exposed bare alloy is of different corrosion potential with the oxide film and therefore a local micro-galvanic cell may form. This may subsequently lead to accelerated metal dissolution and metal-ion release. The predominant corrosion reactions during the tribo-corrosion processes are likely to be:

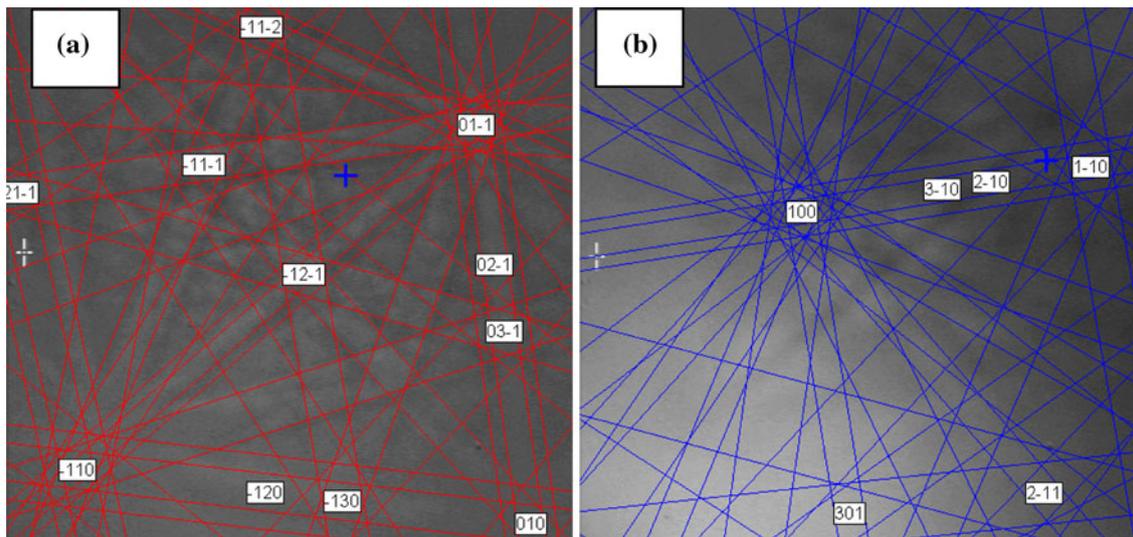
Figure 5 shows Kikuchi patterns [13] obtained from EBSD map which correlates to the indented area shown in Fig. 4b. According to EBSD phase mapping, a FCC structure is the predominant crystal structure for the

**Fig. 5** Kikuchi pattern obtained for microindent shown in Fig. 4b. **a** Undamaged surface (Region I) and **b** deformed surface (Region II)

undeformed material (Region I), which is featured by the pattern centred at  $[\bar{1}10]$ . Although there may be traces of martensite present in the ‘as cast’ samples due to the casting process, such martensite has not been identified from the current EBSD analysis on the polished/etched surface. Hexagonal Close Packed (HCP) phases (possibly as a result of strain-induced phase transformation, SIT) were only found at the points where severe deformation has taken place (e.g. Region II). A martensitic transformation takes place, resulting in a HCP structure featured by the  $[100]$  direction in the Kikuchi pattern. This also gives rise to the orientation relationship:  $\{111\}_{\text{FCC}}//\{0001\}_{\text{HCP}}$  and  $\langle 2\bar{2}0 \rangle_{\text{FCC}}//\langle 2110 \rangle_{\text{HCP}}$ . This conforms with the crystallographic relationship between FCC and HCP as seen for pure cobalt [14].

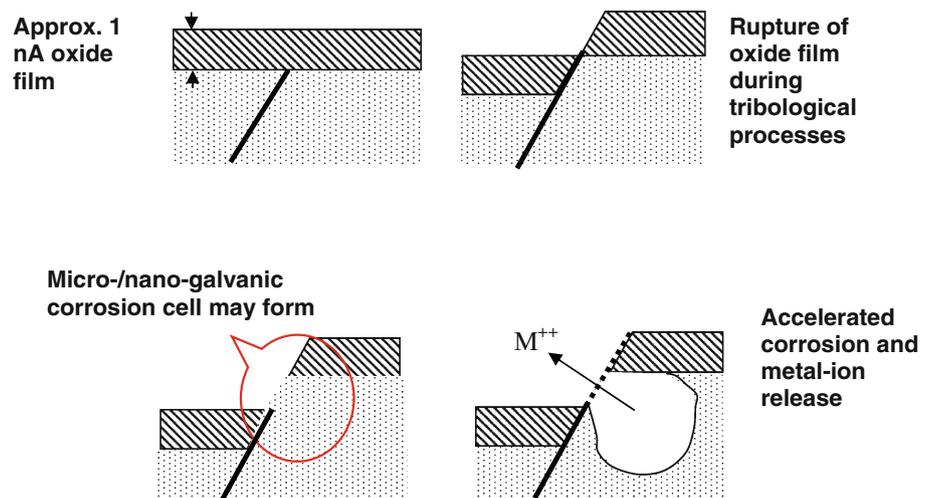
**Fig. 6** Slip line formation results in corrosion cell which induces accelerated corrosion and metal-ion release [16]

Figure 6 illustrates the depassivation and partial surface oxide film rupture caused by the slip line formation. The oxide film formed on the CoCrMo surface ruptures under the shear stress/plastic deformation. As the rupture of passive film also occurs outside the indent via slip line

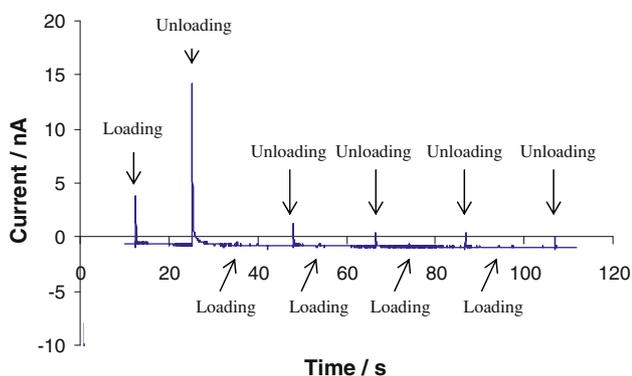
Figure 7 shows the current noise collected during the multiple indentation process in 0.9% NaCl solution. The current peak and charge released are both significantly greater for the first indentation cycle as compared with those at the second and the subsequent indentations. This could be due to the plastic deformation that takes place during the first indentation, while elastic deformation is predominant for the second and subsequent indentations [17]. The indent size (approx. 100  $\mu\text{m}$  diagonally) and profile of a multiple indent appear to be similar to those seen for single indentation.

**Fig. 7** In situ electrochemical current noise of multiple ( $\times 5$ ) Vickers micro-indentation made in 0.9% NaCl under 9.8 N applied load

Figure 8 shows the multiple indentations performed in 25% BS under the same indentation conditions as for the 0.9% NaCl tests, which gave rise to a similar indent profile and current response as seen in Fig. 7. The current peak during unloading is always larger than that during the respective loading process. The current peak and the charge released are approximately constant for the second and subsequent loading/unloading cycles, since after the first

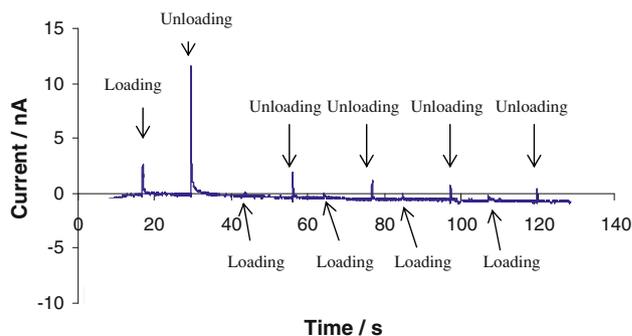
**Fig. 8** In situ electrochemical current noise of multiple ( $\times 5$ ) Vickers micro-indentation made in 25% BS under 9.8 N applied load

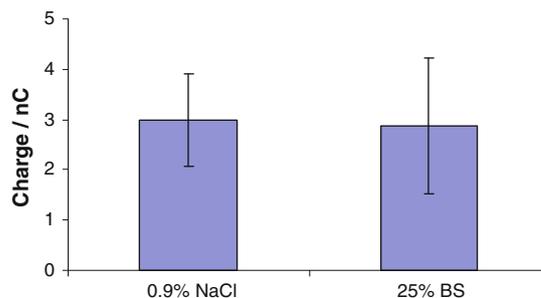
**Fig. 9** Charge generated in 0.9% NaCl and 25% BS test solutions during the first micro-indentation unloading, error bars based on three repeated tests

The higher peak current resulting from the unloading process of the first indentation cycle corresponds to the major current flow event throughout the multiple cycle test. The charge generated during the unloading process was determined using Faraday's law and shown at similar levels for both the 0.9% NaCl and 25% BS solutions, see Fig. 9. According to a previous study [12], the surface oxide film thickness of cast CoCrMo is about 0.88 nm. Assuming during repassivation, the anodic current flow is for oxide film repair only (reformation of  $\text{Cr}_2\text{O}_3$ ), the percent area of film being repaired (repair %) within the deformed region during the first loading/unloading cycle is about 6% of the total deformed area. The detailed calculation can be found in the Appendix. Repair % would be lower if the metal dissolution is taken into account for the anodic current generated; however, the extent of metal ion dissolution is difficult to be quantified in this study. It can be suggested that the CoCrMo is only subject to partial surface oxide damage under the indented area during the indentation process.

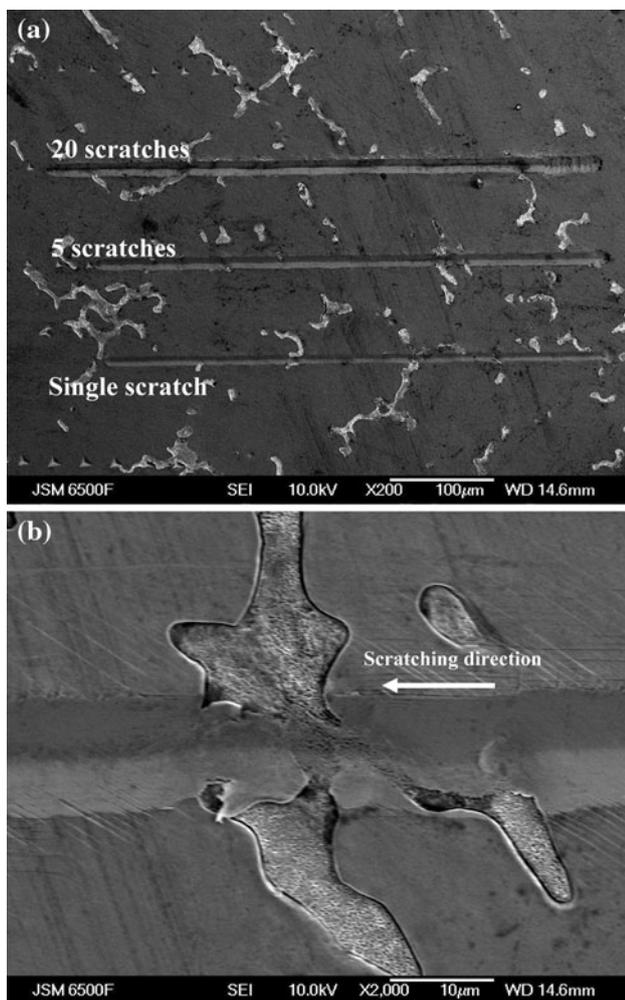
Figure 10a shows a typical example of single/multiple scratches made on CoCrMo surfaces, and Fig. 10b shows a close-up image of a multiple scratch (5 passes). The dominant features of the microstructures were deformation of cobalt matrix and carbide, as well as the development of numerous intersecting slip lines, as have been seen from Fig. 4. These features were a result of the plastic deformation of the alloy. According to Shetty et al. [15], the coarse slip bands are evidence of the planar slip character which should be expected in a FCC Co-rich matrix of low stacking fault energy. In [15], slip band cracking has also been observed in the scratch groove which was accompanied by SIT (FCC to HCP). According to the EBSD

**Fig. 10** **a** Single and multiple scratches on CoCrMo and **b** high-magnification image of a 5-pass scratch. Test conditions: load = 200 mN, scratching speed =  $100 \mu\text{m s}^{-1}$ , scratch distance = 1000  $\mu\text{m}$

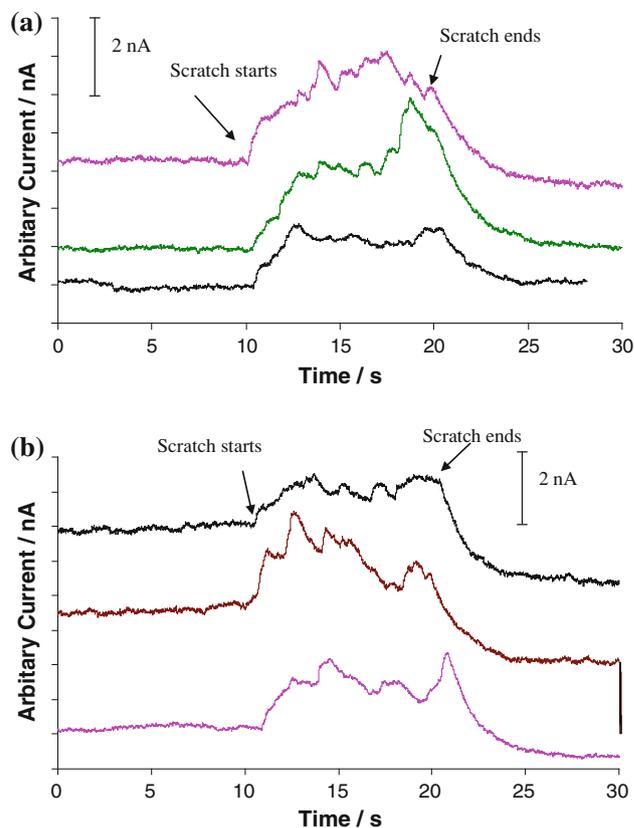
In order to understand the effects of nano-scratching on the corrosion behaviour of the CoCrMo alloy, scratch-induced corrosion current was measured in situ during the single scratch test in 0.9% NaCl and 25% BS test solutions, respectively. Figure 11 shows the typical examples for current noise caused by scratching in both test solutions. The baseline current has been off-set for clarity.

It can be seen from Fig. 11 that there is an increase in the current level as the scratch starts corresponding to the rupture of the surface oxide film (depassivation) due to local plastic deformation. The gradual increase of current at the onset of the scratch may be due to the loading process of the diamond probe which takes about 1 s. The current level during scratching is generally 1–2 nA higher than the baseline current, although the current pattern (fluctuation) varies in different tests. The scratch current variation can be attributed to the fact that each scratch was made at a different location on the CoCrMo specimen surface, and the absolute current response will be sensitive to the surface

**Fig. 11** Current profiles induced by three single scratch tests: **a** 0.9% NaCl and **b** 25% BS, at an applied potential of  $-130 \text{ mV}$  versus Ag/AgCl. Test conditions: load = 200 mN, scratching speed =  $100 \mu\text{m s}^{-1}$ , scratch distance = 1000  $\mu\text{m}$

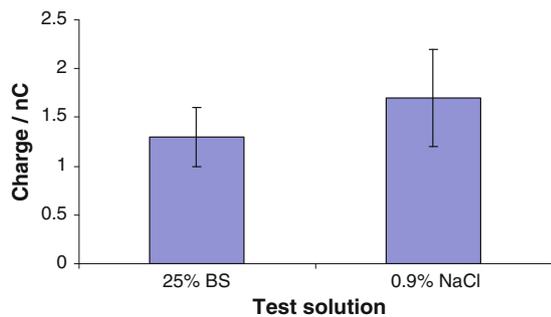
**Fig. 12** Charge generated in 0.9% NaCl and 25% BS test solutions during nano-scratch testing, error bars were obtained based on three repeated tests

As shown in Fig. 12, the total charge transferred during the scratching process (up to the point where indenter stopped sliding, not including the repassivation period) is about  $1.3 \times 10^{-9}$  and  $1.7 \times 10^{-9}$  C for 25% BS and 0.9% NaCl, respectively. Assuming the current flow due to metal-ion release is negligible and electron transfer was only associated with the oxide reformation, the total repaired oxide film area is only about 15 and 20% of the total scratch area for scratches made in 25% BS and 0.9% NaCl, respectively. Although some literature suggests proteinaceous material could act as cathodic inhibitor and thereby hinder charge transfer [10, 18], the presence of an adsorbed protein could also form an organometallic tribofilm which will protect the surface from mechanical damage and ion release [19], the effect of the test solutions on the level charge transfer cannot be clearly discriminated due to the relatively high (20–30%) variation in data.

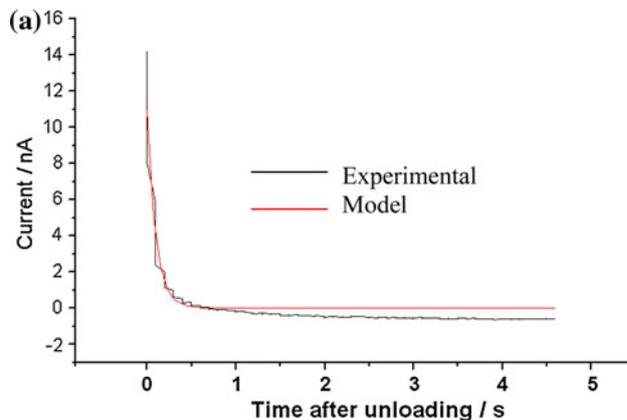
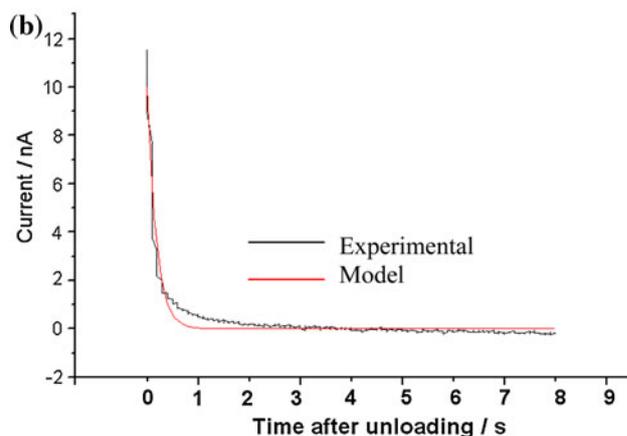
**Fig. 13** Curve fitting for the repassivation process after wet-cell microindentation (1st unloading): **a** 0.9% NaCl and **b** 25% BS

The electrochemical process involved in microindentation has been discussed in Sect. 3.1, the repassivation process immediately after the intense current peak of first loading/unloading cycle can be closely described by a first-order exponential decay function (Eq. 4) for tests done in 0.9% NaCl and 25% BS solution, Fig. 13. The repassivation time constant,  $\tau$ , can be extracted from the fitted curve, and the

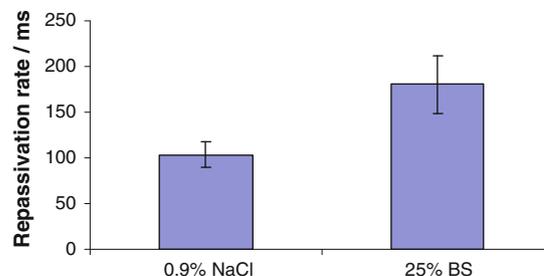
**Fig. 14** Repassivation time for 0.9% NaCl and 25% BS test solutions resulted from the first unloaded microindentation

value has been found to be greater for the 25% BS test (about 180 ms) than that for the 0.9% NaCl test (100 ms), Fig. 14. These results are comparable with [20], and the greater time constant found for 25% BS solution could be attributed to the charge inhibiting effect of adsorbed proteinaceous materials, which hinders the charge transfer required for the repassivation process. Yan et al. [21] also suggested that the constituents of bovine serum can accelerate ion release and passive film breakdown. The gradual re-establishment of the electric double layer across the metal/electrolyte interface may also contribute to the slow recovery of current.

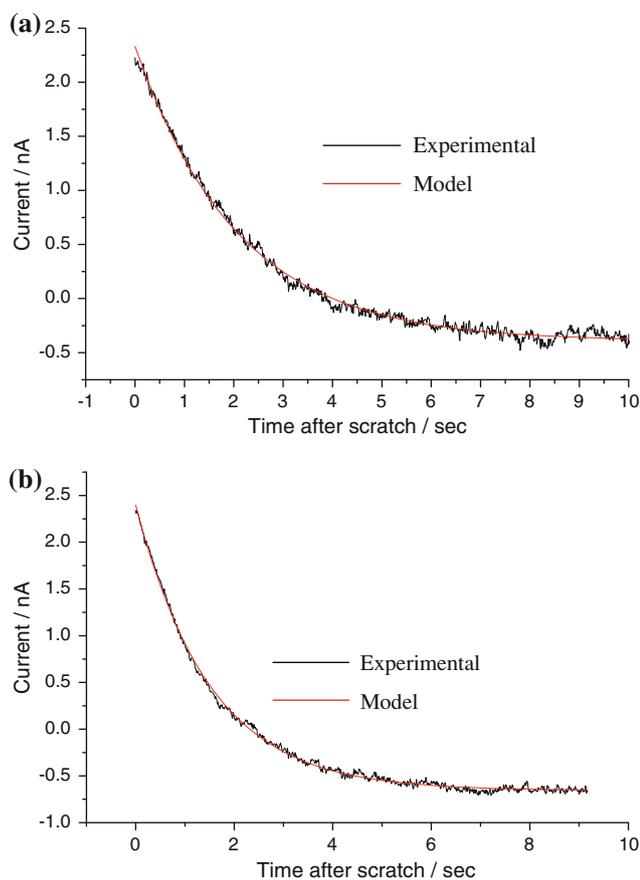
The repassivation kinetics resulting from a single scratching test has been plotted in Fig. 15, which also follows a first-order exponential decay (Eq. 4). The repassivation takes a significantly longer time (around 1.5 s)

**Fig. 15** Curve fitting for the repassivation process after a single scratch: **a** 0.9% NaCl and **b** 25% BS

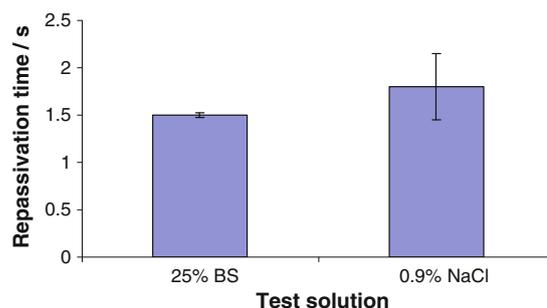
**Fig. 16** Repassivation time for 0.9% NaCl and 25% BS in single scratch tests

compared to the wet-cell micro-indentation results for both test solutions; however, overall the single scratch repassivation times for the two test solutions are not significantly different, Fig. 16.
