NONCONTACT ASSESSMENT OF HIGHWAY SURFACE VULNERABILITY TO WATER INDUCED DAMAGE

Millar, P., & Woodward, D. (2011). NONCONTACT ASSESSMENT OF HIGHWAY SURFACE VULNERABILITY TO WATER INDUCED DAMAGE. *International Journal of Pavements*, 10(1-2-3), 39-49.

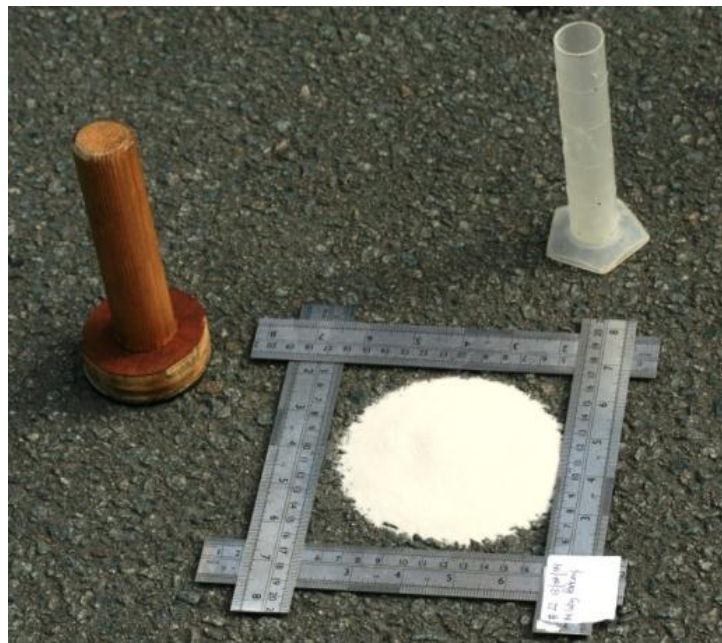
Figure 1: Typical image capture configuration

The simple arrangement of stainless steel rules was used to provide scale for subsequent processing of the stereo images. The orientation of the images is arbitrary as a result but the models can be transformed to simulate camber or crossfall and can be used to generate a theoretically unlimited number of profiles in any direction and orientation. In order to characterize the surfaces, the transformed images were meshed at a 0.2mm interval. A typical surface model is shown in Figure 2.

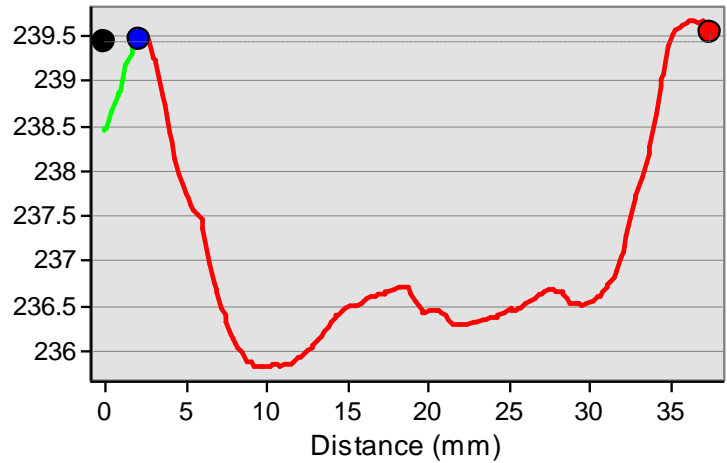
Figure 4: ArcGIS profile through potential area of entrapped water

surfaces they were depth banded at 0.1mm intervals commencing at the lowest elevation for each model. The asphalt concrete surface shown in Figure 2 is shown on plan in Figure 3 classified at a 0.1mm vertical interval in order to enhance the surface relief. To avoid unnecessary occlusion the contours are not displayed. A number of potential areas of water entrapment are circled. The profile of an area though the section line in the upper left quadrant is shown in Figure 4. The potential for water and ice to accumulate and become entrapped is clearly shown in the profile.

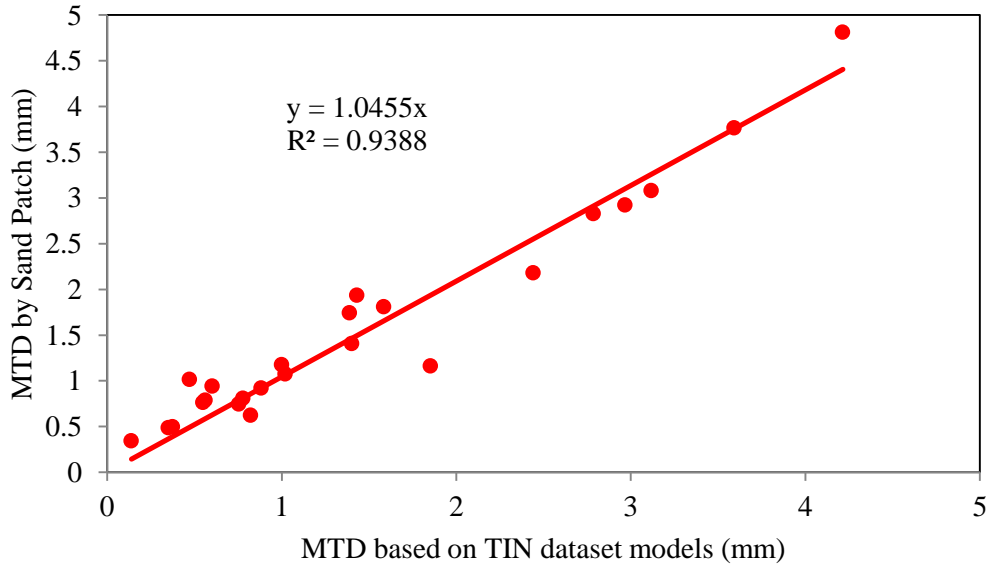
Figure 7: Correlation of MTD estimated by sand patch and DEM from the TIN dataset models

Correlation of mean texture depths (MTD) based on sand patch and volumetric estimation from the TIN dataset models found a linear relationship with a R^2 value of 0.939 as shown in Figure 7. Elevation frequency analysis of the data sets indicated that the majority of surface elevations are normally distributed. Figure 8 and 9 compare the distributions for a 14mm/6mm chip seal and 14mm size chip seal. Figure 8 shows a normal distribution whilst Figure 9 shows the heavily trafficked 14mm single size chip seal characterised by pronounced areas of discrete surface relief. Surface elevations are expressed in millimetres above the lowest elevation value for each model. Figure 10, 11 and 12 show the original image, raster and 3D model for the 14mm chip seal. The 3D model clearly shows the variation of the surface texture.

The ability of depth classified models to indicate risk of water entrapment has been shown. Figures 2 and 12 show that surface relief can be visually well represented. The surface micro-topography and raster overlays show good correlation as shown in Figures 5, 6 and 11. The mean texture depth estimated from the 3D models correlate strongly with that determined using the sand patch method as shown in Figure 7 i.e. 3D methodology is robust and establishes a level of confidence.

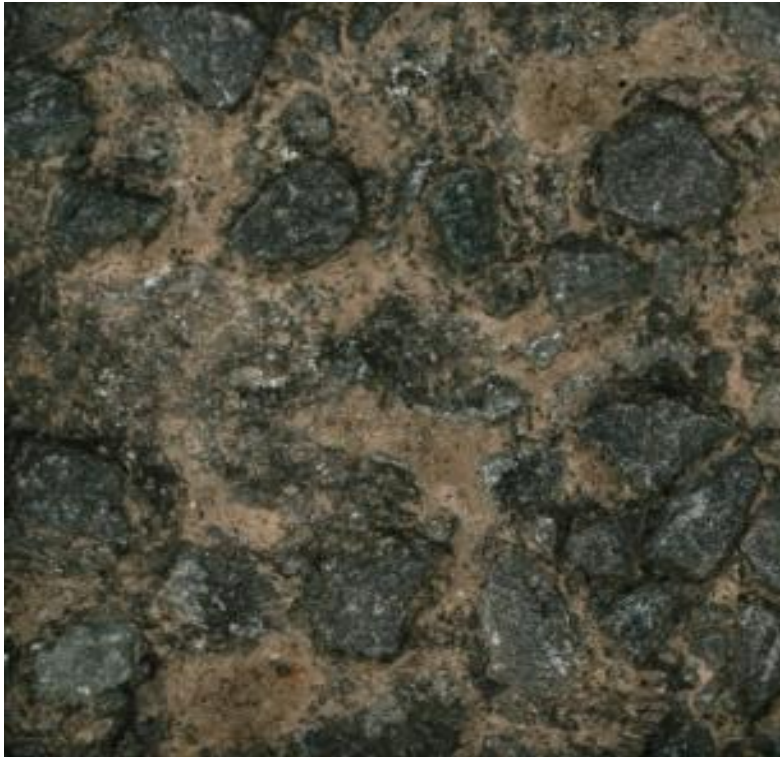
Figure 10. Original digital image of the 14mm chip seal

Elevation frequency distributions such as that shown in Figure 9 are heavily skewed and show distinct peaks. Figure 10 shows the model corresponding to Figure 9 which displays pronounced protrusion of aggregate particles on a heavily trafficked surface. According to Kerr et al. [9] a dataset containing a few extreme values can skew frequency distributions significantly. This can indicate a level of error or bias in some types of research study due to subjectivity introduced by the researcher. As the authors of this study had no influence on the surface relief from which the models were constructed it seems reasonable to conclude that the skew is indicative of some aspect of the surface properties.

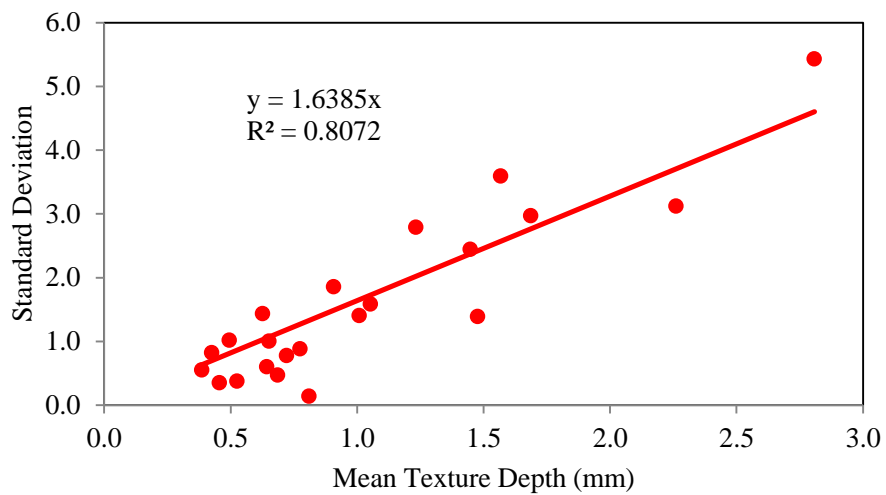
Figure 13. Correlation of mean texture depth and standard deviation

Correlation of mean texture depth and standard deviation of the elevation frequencies found a R^2 value of 0.807 as shown in Figure 13. However, when the area of potential water entrapment was correlated with mean texture depth poor correlation was found as shown in Figure 14.

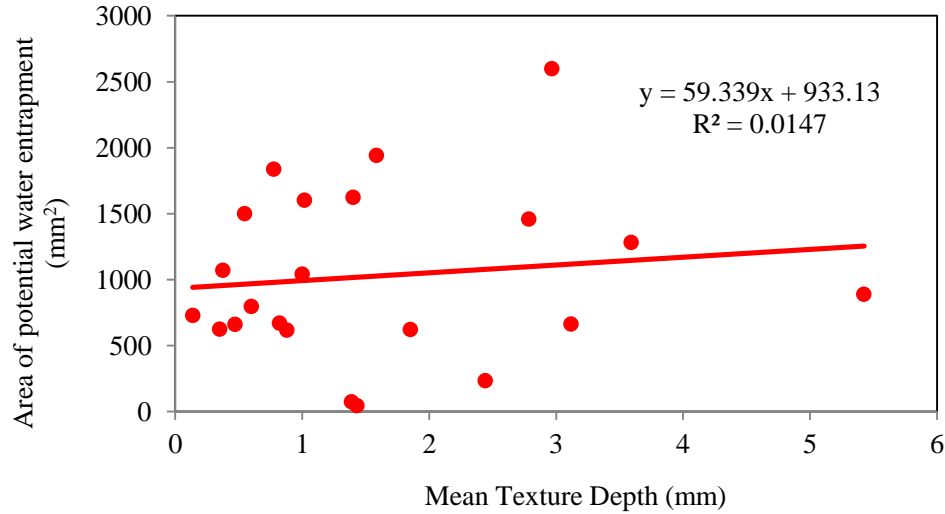
Figure 14. Plot of mean texture depth against area of water entrapment

Figures 14 and 15 show poor correlation between area of water confinement and Risk Index with mean texture depth measured using sand patch. Figure 14 and 15 indicate that a low textured surface may show high risk whilst a highly textured surface may have a relatively low risk of water entrapment. The plot of Risk Index against mean texture depth shows no obvious correlation with surface type. This suggests that simple estimation of texture depth gives limited indication of a surface's capacity for surface water retention. It also reinforces the suggestion by Millar and Woodward [1] that the concept of assessing the performance of a surface from a single geometry is fundamentally flawed and offers little insight into the interactions at the tire-surface interface. As yet, the authors are not aware of a relationship between Risk Index and traffic safety.

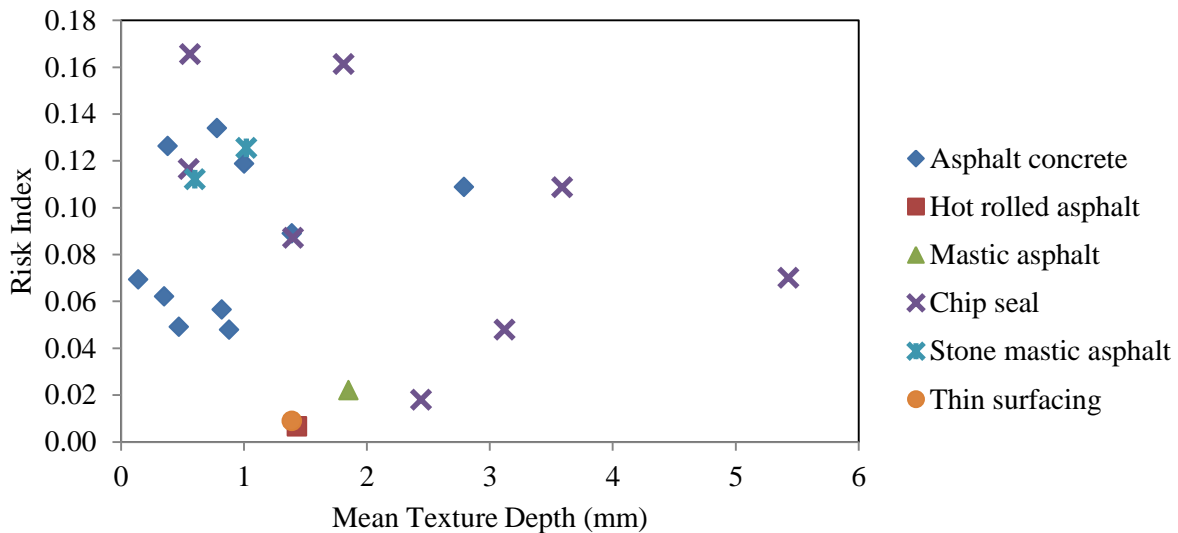
A simple Risk Index was determined for each surface based on the ratio of the plan area of potential water entrapment to the total plan area of the sample. The Risk Index values ranged from 0.007 to 0.165 with a median value of 0.087. Figure 15 shows the resulting plot and poor correlation between these two values. The data in Figure 15 has been subdivided into the different types of surfacing to see if this apparent lack of correlation could be improved. The plot shows that such sub-division does not improve the correlation.

Figure 15: Plot of Risk Index against mean texture depth for all samples
