Dry stone walls as sediment traps: example from Rydal

Wilson, P., & Lord, T. (2018). Dry stone walls as sediment traps: example from Rydal. *Proceedings, Cumberland Geological Society*, 8(4), 477-491.

DRY STONE WALLS AS SEDIMENT TRAPS: EXAMPLE FROM RYDAL

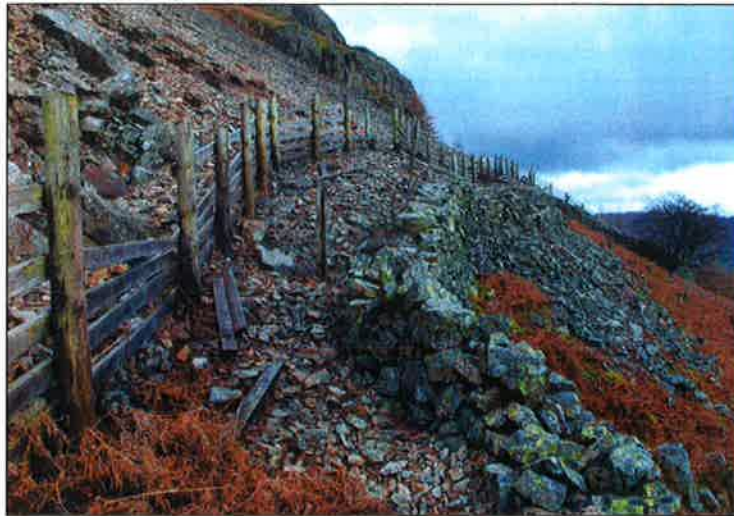
Figure 1. Wall above the Old Dungeon Ghyll Hotel in Great Langdale overtopped by downslope movement of talus.

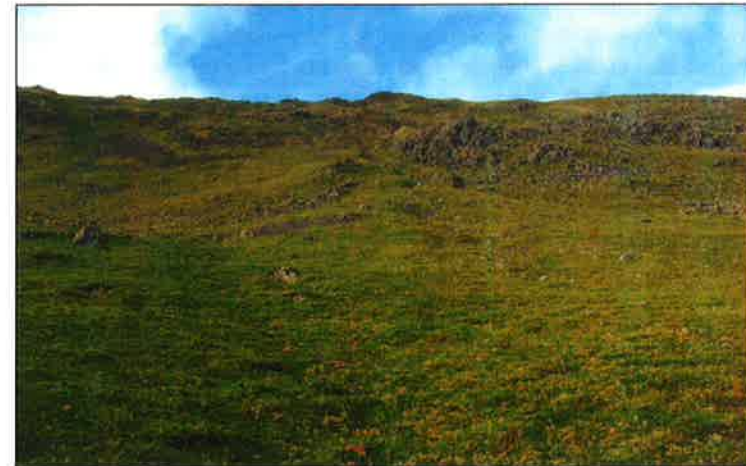
Figure 3. Vegetated hillslope above Fan 1. There is no evidence of recent surface flow or sediment transport down this slope, although shallow palaeochannels are present.

Fan 1: This fan (Grid Reference NY 361090) is immediately south of Dalehead Close where the dry stone wall descends the hillside obliquely and meets the southwest angle of the Dalehead Close wall. Debris is banked against the wall for a distance of 47 m and has reduced the visible height of the wall to 0.25 - 1.1 m. To the south of the fan wall height is 1.85 m and to the north it is 1.4 m. The fan and its feeder gully are predominantly vegetated with only a few small areas of surface debris evident (Fig. 3).

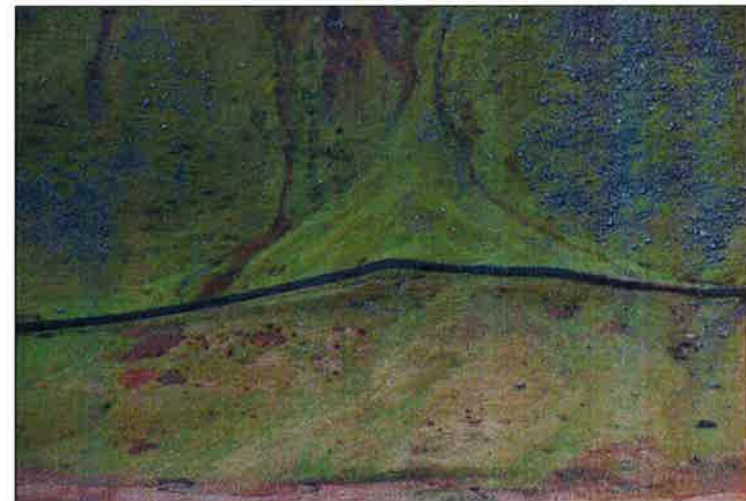
Figure 4. Fan 2 as seen from across the valley. The fan surface is almost totally vegetated although palaeochannels and levees are still evident. Water flow is currently to south (left) and north (right) of the fan, as indicated by the rush-infested (darker vegetation) drainage lines.

Fan 2: At Grid Reference NY 361093 the Dalehead Close wall is totally obscured on its upslope side for a distance of 20 m, and for another 34 m the wall height is less than 1.5 m. Wall height on either side of the fan is 1.5 - 1.75 m. The fan surface is vegetated, with palaeochannels and levees evident, and current channel flow is along the margins of the fan. Figure 4 shows the fan from the opposite side of the valley, from where the upslope-facing height of the wall cannot be seen.

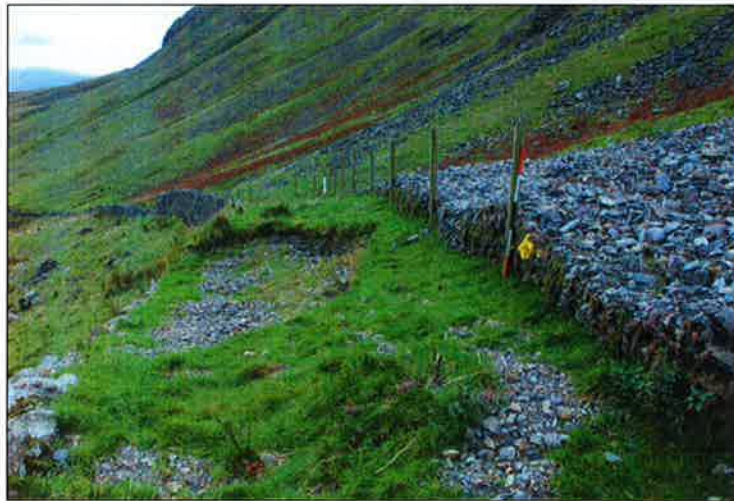
Figure 5. The surface of Fan 6 with recent debris from the December 2015 storms trapped against the fence. The vegetated surface of the fan to the left of the fence is slightly higher than the wall.

Fan 6: This fan, at Grid Reference NY 359099, has a cover of recent debris, 0.5 - 0.6 m in thickness, trapped by the post and wire fence (Fig. 5). Prior to this input of sediment, the vegetated fan surface stood slightly above the capstones of the wall, which were obscured for a distance of 20 m. The recent debris extended for 22 m along the fence and in plan it tapered upslope for 20 m to the foot of an incised channel. The debris is probably a product of the December 2015 storms. Wall height south and north of the fan is 1.3 - 1.6 m.

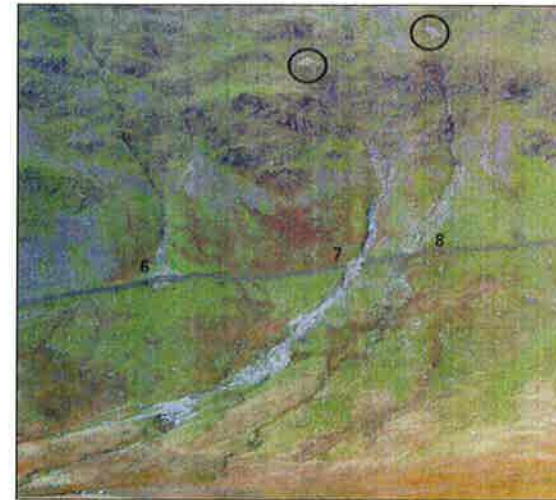
Figure 6. Fans 6, 7 and 8. Shallow landslip scars (ringed) are present near the heads of the gullies that feed Fans 7 and 8. Prior to December 2015 debris accumulation upslope of the wall at Fans 7 and 8 was very limited in its extent and thickness.

Fans 7 and 8: These two fans are adjacent at Grid Reference NY 360100 (Fig. 6). Prior to the storms of December 2015 water from both gullies was able to pass through gaps in the wall and carry fine sediment to the valley floor; the field evidence suggests that any pre-existing fans were of limited extent and thickness. As a consequence of the storms the wall was breached for lengths of 9 m (Fan 7) and 3.5 m (Fan 8), and at the latter site some debris remains level with the top of the wall adjacent to the breach. At both places the wall has been rebuilt and water is free to flow through as before.

Immediately upslope of Fan 7 is an incised channel 1 - 2 deep, and near the head of each gully there is a shallow landslip scar (Fig. 6). It is inferred that the saturated debris from these landslips was transported rapidly downslope and caused much coarse sediment to be trapped against the wall, and destroyed two short segments of the wall where the streams passed through.

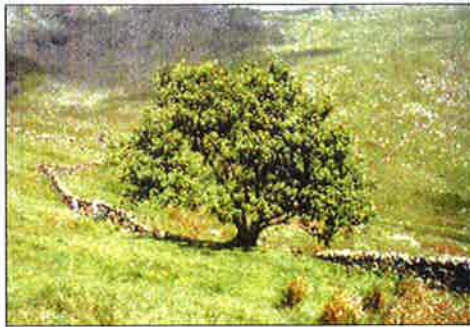
Figure 7.
Downslope view of
Fan 10 showing a
substantial rowan tree
growing from the debris
where it is level with
the top of the wall.

Fan 10: The wall is obscured by fan debris for a distance of 9 m and partly obscured for a further 22 m at Grid Reference NY 361104. Wall height beyond the fan margins is 1.7 m. A substantial rowan tree is rooted in fan debris where it abuts the wall (Fig. 7). The fan surface has vegetated palaeochannels and scattered boulders. Active channels occur along the south and north margins of the fan.

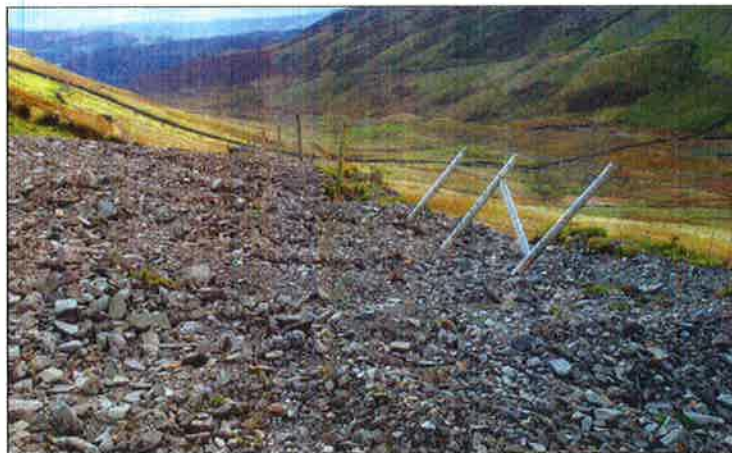
Figure 8. The debris of Fan 11 is level with the top of the wall and has spilt over into the enclosure. It has also disturbed the fence that was built to maintain the boundary and prevent sheep from jumping into the enclosure.

Fans 11 and 12: These adjacent fans are on the east side of Dalehead Close (Grid Reference NY 366096) and on both the debris is unvegetated. Fan 11, fed by a single incised stream channel, has obscured the 1.5 m high wall for a distance of 18 m (Fig. 8). In contrast Fan 12 is a compound area of debris brought downslope by several shallow stream channels. Debris from these channels extends alongside the wall for ~150 m and in the past may have overtopped or breached the wall. The present wall in this area looks to have been rebuilt recently but does not rise more than 1 m above the debris. While both fans are likely to have had debris added to them during December 2015, they were first recorded as active fans in 2004 by one of the authors.

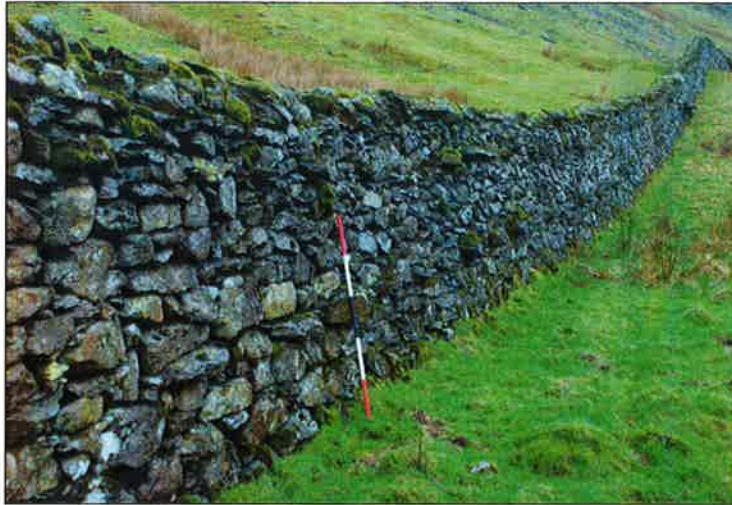
Figure 9. A section of the downslope-facing Dalehead Close wall with rows of projecting through stones at 0.5 m and 1.2 m above base. The survey pole divisions are at intervals of 0.2 m.

Another aspect of the structure of the Dalehead Close wall enables it to be dated more precisely. Clearly visible in lengths of the structure are two rows of carefully placed through stones that project from the wall (Fig. 9). Narrow-top double walls with regular arrangements of one or more rows of through stones are documented in eighteenth century specifications for new build walls (Raistrick, 1946). It is very likely that the Dalehead Close wall was built sometime between the mid-eighteenth and early nineteenth century, and very likely built to specifications by a professional walling contractor.

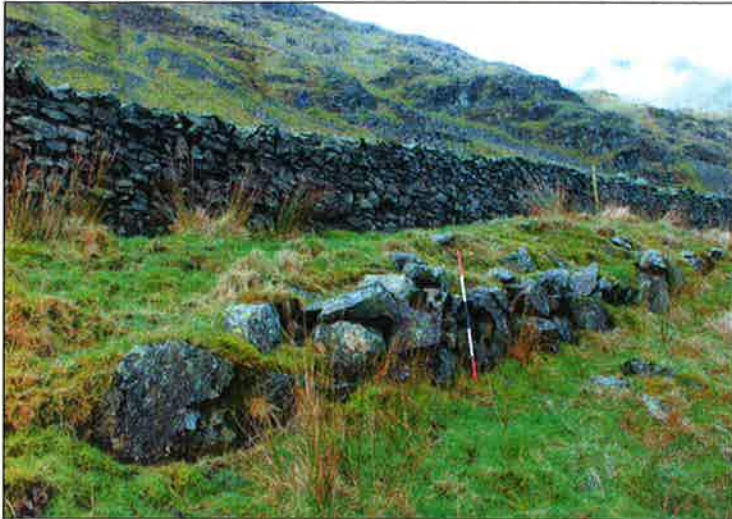
Figure 10. Remains of a former wall downslope of the extant wall at Dalehead Close. The survey pole divisions are at intervals of 0.2 m.

There is some evidence for a precursor wall, as implied by the 1655 valuation (Armitt, 1916), at several locations on the downslope side of the extant wall along its western arm. At these sites, banks of large boulders aligned parallel with the extant wall are visible (Fig. 10). In some places, the extant wall is directly on top of the boulder bank, in others the boulder bank is 1-2 m downslope of the wall. From this field evidence an inference might be that wholesale rebuilding of the Dalehead Close wall as a narrow-top double wall took place no earlier than the middle of the eighteenth century and no later than the middle of the nineteenth century.
