Experimental Studies on the Behaviour of Headed Shear Studs for Composite Beams in Fire

Published in:
Steel and Composite Structures

Experimental studies on the behaviour of headed shear studs for composite beams in fire

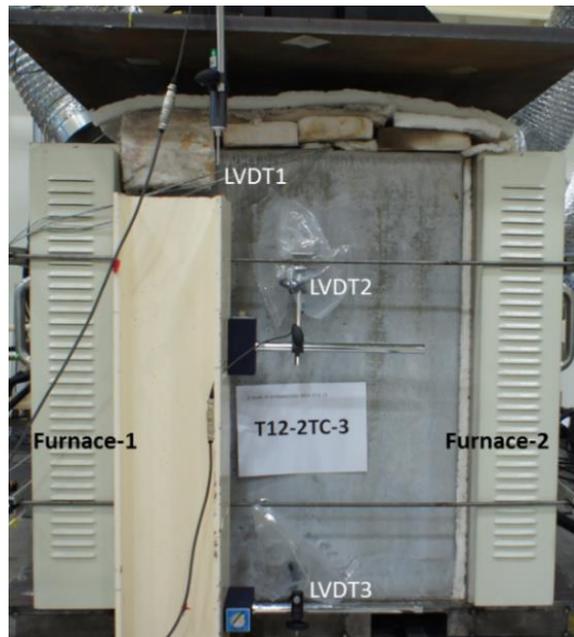
Fig. 3 Furnace and LVDT setup for the high-temperature experiment

An applied load, relative slip and temperatures were measured during the push-out tests. A square plate swivel jig was placed between the steel beam and actuator which has the maximum capacity of 2500 kN. Three linear variable differential transformers (LVDT) were installed to measure the vertical and lateral displacement at each slab as shown in Fig. 3. A relative slip between the loading plate and concrete slab was obtained using LVDT 1 and LVDT 2. K-type

thermocouples were used to collect the temperatures of the web and flange. The gas temperature in the enclosure space between the specimen and electric furnace was measured at the middle height of the two levels of the shear stud.
