Reconstruction of the Grenfell Tower Fire—Thermomechanical Analysis of Window Failure During the Grenfell Tower Disaster

Abstract. Observations and numerical studies have allowed an understanding the fire development inside apartments and over the façade during the Grenfell Tower fire. During these analyses, the highlighted need was for a deeper investigation into the failure of windows during the fire. This detailed and complex model for window failure validates the thermal breakage criteria used in fire simulations of the whole Grenfell Tower fire. However, the present investigation is dedicated to a single pathway for the influx of fire and toxic smoke. Other pathways from the façade to the apartments, such as the melting of elements surrounding the window frame, are not addressed here. To analyse window behaviour during fire, Finite Element Method thermomechanical modelling is used. First, a heat transfer analysis is performed for windows subjected to the external flames from the identified façade fire scenario. The thermal loads evaluated from the fire are applied to the window structures to estimate their failure times. Two window casement configurations, closed and tilted-i

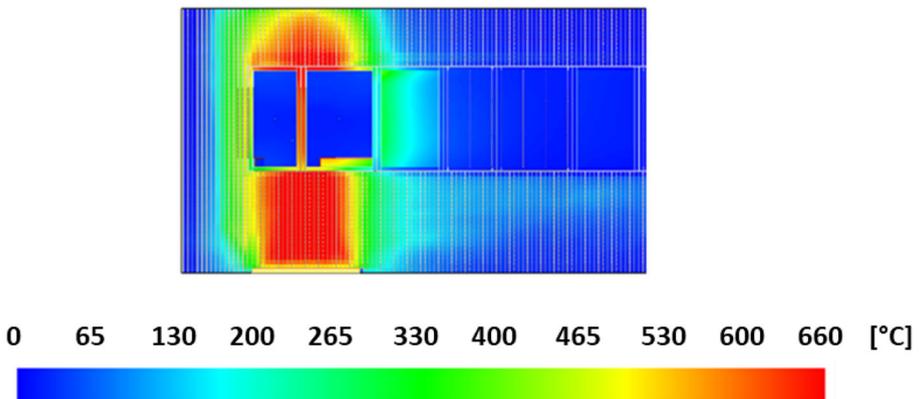
Figure 5. Numerically modelled temperature of the external window on the 5th floor, directly above Flat 16 of the Grenfell Tower, after 4 min of façade fire exposure [34].

the external frame of the window located at the 5th floor, directly above Flat 16, were subjected after 4 min of façade fire exposure. The heat flux fields applied to the exposed face of the window are addressed in Fig. 6a. The position for each part of the window is indicated in Fig. 6b. These thermal loads are representative not only of fire break-out through a typical window, but also of the developed façade fire during vertical fire spread over the tower, as observed in Fig. 7. At later stages of the façade fire, the numerically estimated thermal loads (in terms of gauge heat flux) on window frames are consistent with the general flux evolution indicated in Fig. 6. The maximum heat fluxes imparted to Parts 1, 5 and 7 of the window frame (Fig. 6b) is about 120 kW/m^2 after 3–4 min of fire exposure, while the minimum heat fluxes evaluated for the lower Parts 2 and 6 and lateral Part 3 of the window frame (Fig. 6b) are between 30 and 70 kW/m^2 . There are differences for the windows attacked thermally during horizontal fire spread where thermal gradients can change slightly. Flames affect Part 8 of the frame before Part 5 (Fig. 6b) but the delay in such horizontal gradients is less than 1 min.

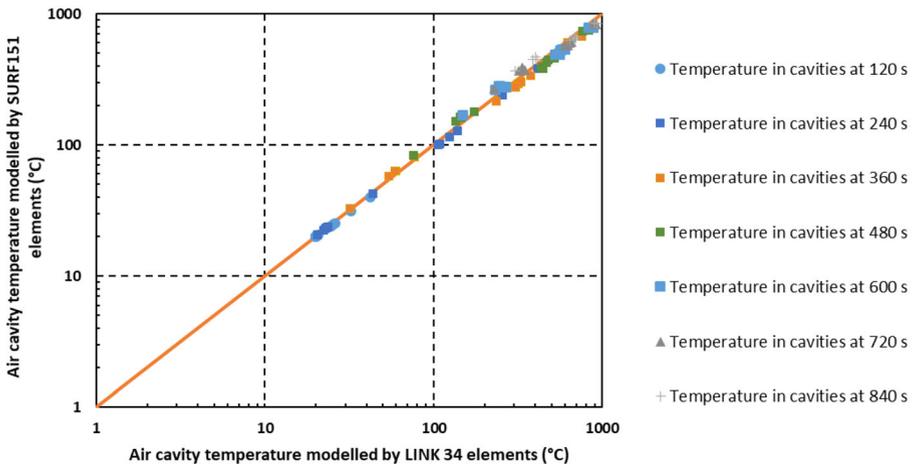
Classical finite element approaches are not adapted to model airflow where finite volume approaches are used. However, some alternative approaches are used to model the stationary airflow. As shown in the previous section, ANSYS convective LINK34 elements are used to model the convection mechanism of heat transfer. In order to evaluate the computations, their results are compared with a second thermal analysis performed using SURF151 elements for convection in the cavities. In this analysis, the average temperature of the cavity is applied to the bulk nodes before each step of the computations. Radiation and convection in the cavities are computed at each time-step based on this temperature. The cavity temperatures are compared for both models based on the inputs, heat fluxes and film coefficients, applied to part 1 of the window (see in Figs. 6, 8). The analysis is performed for 840 s. Figure 10 shows the comparison between these two set of results. The Pearson correlation coefficient (PCC) is 0.986 and the relative error (RE) between two set of results for 840 s of computation is of 1.3%.

Figure 10. Comparison between the bulk temperatures for the modelling of convection by LINK34 elements versus SURF151 elements in the cavities of the window frame.

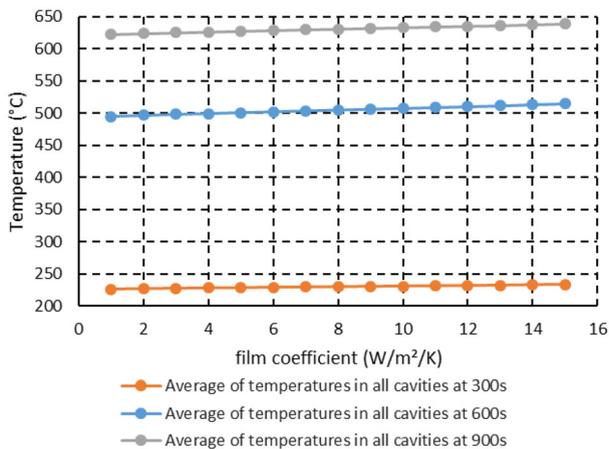
A sensitivity analysis is performed for the convective coefficient in the cavities, for window Part 1 (see in Fig. 6b). Heat fluxes and adapted exchange coefficients are applied to the exposed faces (see in Figs. 6 and 8). Figure 11 presents the average temperature in all cavities at 300 s, 600 s and 900 s. The computations show that the variation of film coefficient in the cavities for this study may be neglected. The average increase of the temperature in a cavity for an increase of $1 \text{ W}\cdot\text{m}^{-2}\cdot\text{K}^{-1}$ of film coefficient is about $0.46 \text{ }^\circ\text{C}$ at 300 s and $1.08 \text{ }^\circ\text{C}$ at 900 s.

Figure 11. Average temperature in all cavities of the window frame at 300 s, 600 s and 900 s.

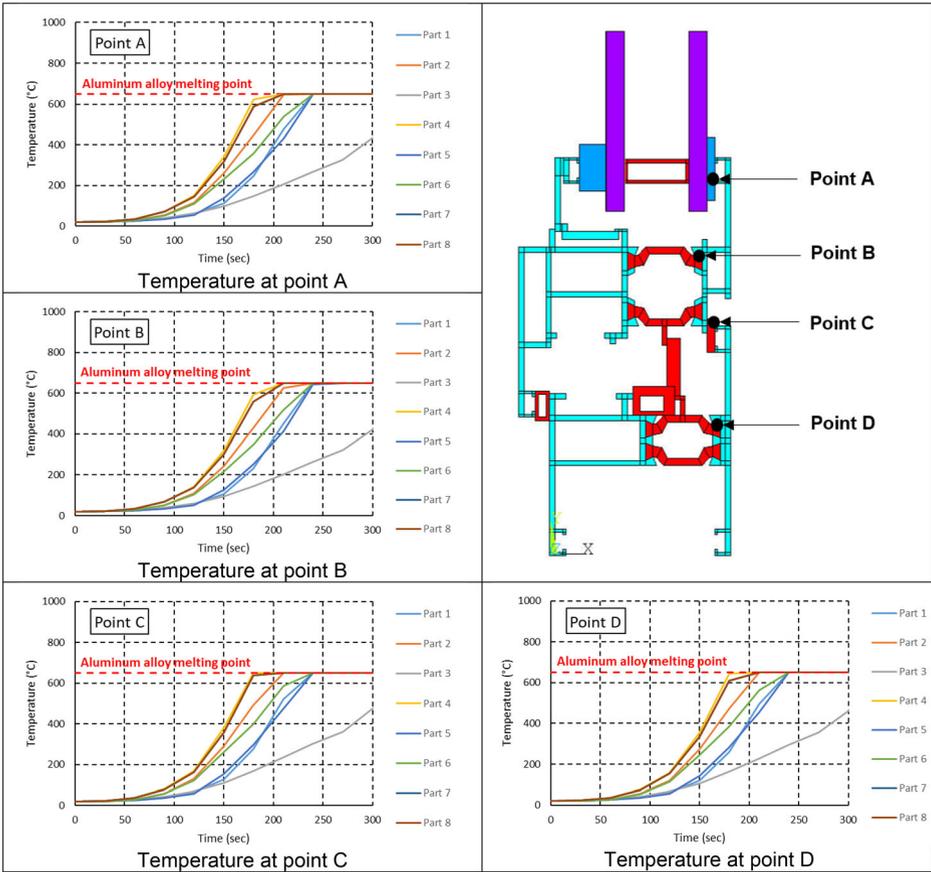
Time-history temperatures are evaluated for all of the frame sides (Parts 1 to 8). Temperatures at four locations A, B, C and D, located close to the polyamide thermal breaks, are indicated in Fig. 12. Temperatures are up to $80 \text{ }^\circ\text{C}$ between 1.5 min (on Parts 4 and 8) and 2.5 min (on Part 3) of external fire exposure of the polyamide thermal breaks, and up to $200 \text{ }^\circ\text{C}$ between 2 min (on Parts 4 and 8) and 4.5 min (on Part 3) of exposure for all positions close to the external side. This is consistent with the numerical observations in [34] where the external fire breaks the left part of the window first. Therefore, the thermal failure of the window frame is expected before 5 min of external fire exposure. This is consistent with the criterion of 4 min for the partial window failure considered in the fire model [34].

Figure 12. Temperature over time, evaluated at four locations (A, B, C and D) in the window frame.

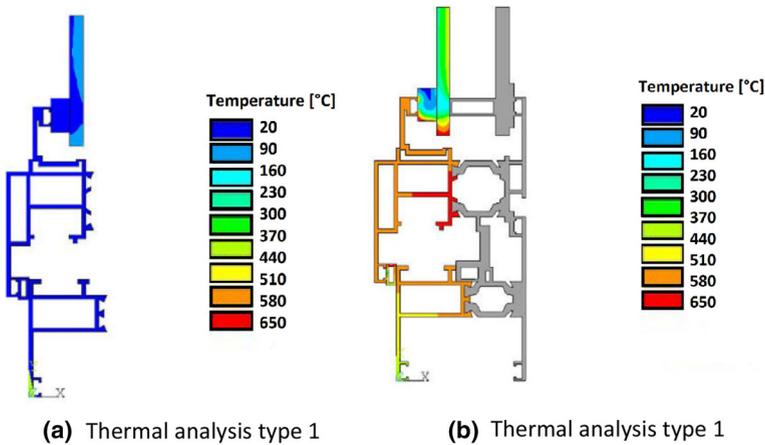
Figure 14. Temperature fields at 240 s of fire exposure for the inner section of Part 8—(a) with external section in place (b) without the external section.

The thermal heating of the internal profile of the window frame, in the above model, is no longer valid after the failure of the outside section of the frame.

Therefore, a new thermal analysis was set up (called thermal analysis type 2). The outside section of the window frame wall is deactivated. Surface boundary elements and conductive elements are removed (so called killed) during the analysis. Then, the new boundary surface elements are created (so called birth) on the inner face of the internal profile at 3 min. The thermal fields for Part 8 of the window frame at 240 s of fire exposure are shown in Fig. 14. Figure 14a shows the temperature field on internal profile of the window frame at 240 s, assuming that the external profile resists thermal heating (thermal analysis type 1). The maximum temperature is lower than 90 °C for the inner profile of Part 8 at this time. Figure 14b shows the temperature field of internal profile of the window frame at 240 s, assuming that the external profile fell away or melted at 3 min (thermal analysis type 2). The temperature of the internal profile, when the external profile has fallen away or melted, indicates that the internal profile may well melt or fall away before 4 min (240 s).

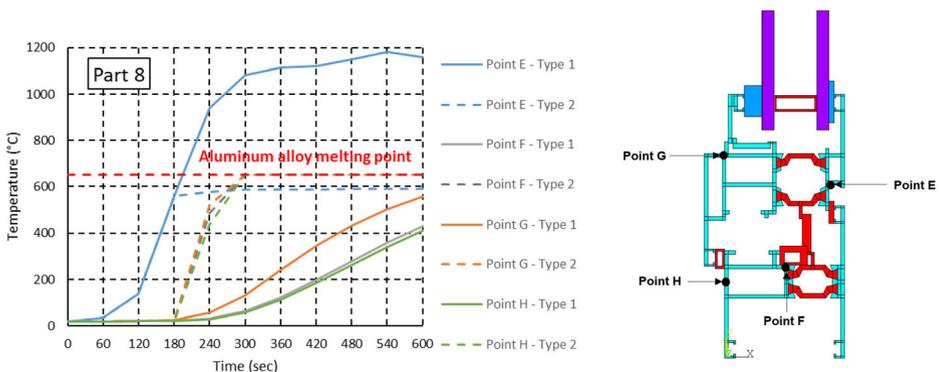
Figure 15 shows the comparison between the temperatures at different points of the window frame for the two types of thermal analysis described above. The temperature is higher than the aluminium alloy melting point (with upper limit of 650 °C) at 180 s for point E for analysis type 1. However, the analysis type 2 assumes that the external profile of the window fails and the temperature at this point does not increase anymore. On the contrary, the computations show that the temperatures are higher after 180 s for points F, G and H. The results of thermal analysis show that the failure of the internal profile of the window frame occurs at about 4 min (250 s), because of aluminium alloy melting.

Figure 15. Evolution of temperature at exposed and on exposed side of frame part 1 at 600 s of fire exposure for two types of thermal analysis.
