A Preliminary Investigation into Geopolymer Cement Mortar's Suitability for Providing Resilient Highway Solutions

B.J. Magee, A. Wilkinson, D. Woodward, S. Tretsiakova-McNally and P. Lemoine

ABSTRACT

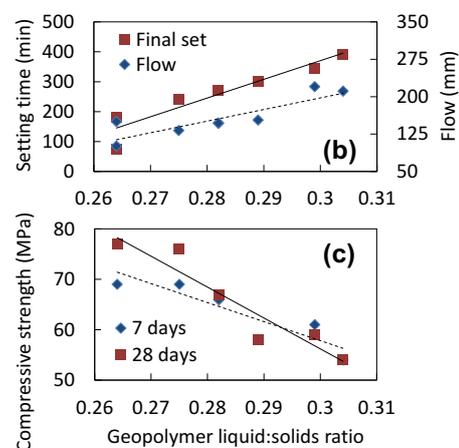
Figure 1. (a) Geopolymer mortar mixture proportions used in Phase 1; Relationship between geopolymer liquid:solids ratio and: (b) fresh mortar properties (flow and final set); and (c) compressive strength (7 and 28 days).

Initial and final setting time ranges for the nine geopolymer mortar mixes were 44-295 and 75-390 minutes respectively (Figure 1(b)). While appropriate for standard mortar applications, this level of performance was recognised as insufficient for rapid-setting patch materials where minimum recommended strength levels are typically required after 2 hours (McDaniel et al, 2014). According to flow characteristics given in BS EN 1015-6 (1999), mix 1 was classed as a stiff mortar (<140 mm), mixes 2 and 5-11 as plastic mortars (140-200 mm), and mixes 3 and 4 as soft mortar (>200 mm) (Figure 1(b)). The Manual of Contract Documents for Highway Works (2016) mandates class C37 (minimum 7 and 28 day compressive strengths of 32 and 37 MPa respectively) for concrete road surfacing material. As shown in Figure 1(c), all of the geopolymer mixes considered exceeded this, with 7- and 28-day compressive strength ranges of 54-69 and 54-77 MPa recorded respectively for the nine mixes considered. Furthermore, the flexural strength of mixes 1, 3, 4, 7 and 8 exceeded the minimum laboratory-based value of 2.4 MPa proposed for rapid-setting patch materials (McDaniel et al, 2014).

Apparent from Figure 1 is the significant influence of geopolymer liquid:solid ratio (i.e. ratio of the sum of water content in the activator and added water to solid metallic silicate content of the activator and the alumina-silicate powder) on both fresh and hardened properties. Similar to the influence of water:cement ratio for Portland cement-based materials, increasing liquid:solid ratio resulted in increasing flows and setting times, and decreasing compressive strengths. In addition, other factors such as paste to sand content have an effect. An example of this is apparent when comparing mixes 1 and 6. While both had a liquid:solid ratio of 0.264, mix 1 had a lower paste:sand ratio (0.55) and corresponding strength (62 MPa) in comparison to mix 6 (0.66 and 77 MPa); indicating an insufficient quantity of paste in mix 1 to sufficiently fill voids between the sand particles, resulting in poor compaction and interfaces between sand particles and geopolymer paste.

Mix 6 was selected for further scrutiny in Phase 2 owing to its optimum compressive (69/77 MPa at 7/28 days) and flexural (2.3 MPa at 28 days) strength in Phase 1. However, as the setting times and rate of strength gain noted for mix 6 were deemed inadequate for rapid repair applications, additional mixes were considered with increasing quantities of calcium-containing materials; an established approach for accelerating geopolymer reactivity (Hunnicut, 2013). In addition to mix 6, three mixes with 40, 50 and 60% by mass replacements of BanahCEM powder with GGBS (labeled 6-40, 6-50 and 6-60% respectively) were prepared in accordance with the same mixing processes as used in Phase 1 (Banah, 2011).

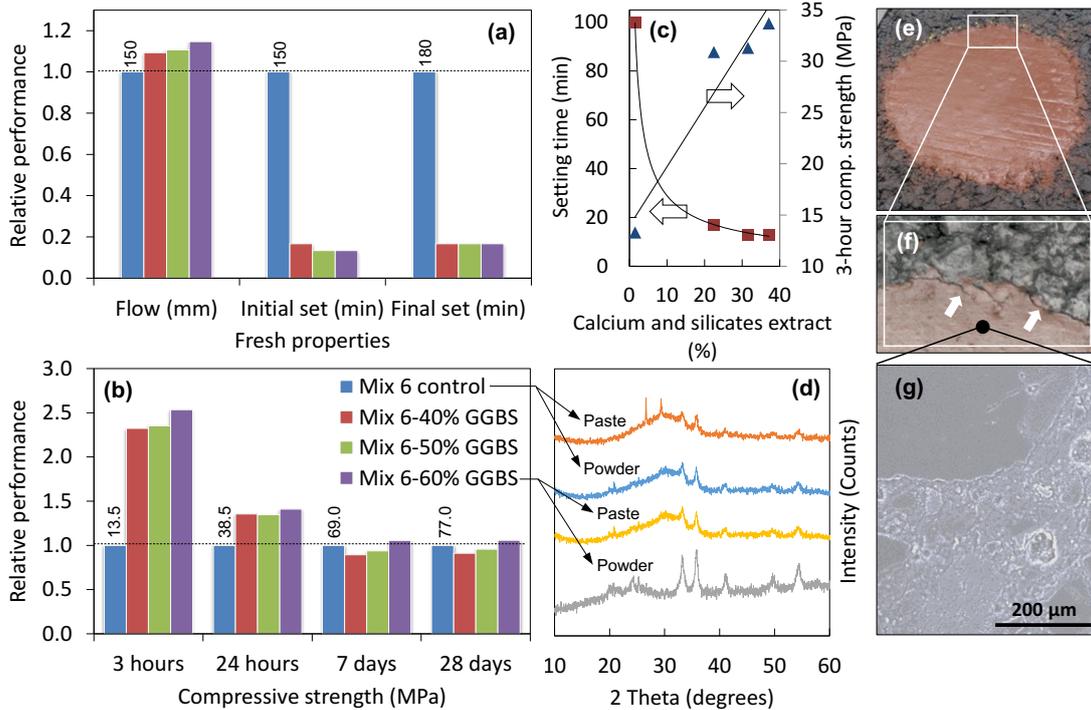
Figure 2. (a&b) Performance of GGBS-based geopolymer mortar mixes relative to a non-GGBS control (mix 6 – see Figure 1(a)); (c) Influence of calcium content on geopolymer mortar setting time and 3-hour compressive strength; (d) X-ray diffraction traces for geopolymer cement powder and paste specimens; (e) Rapid patch repairs test specimen prior to accelerated wear testing; (f) Surface edge cracking of patch repair specimens after exposure to 2,000 wheel passes; and (g) Representative SEM image of BanahCEM mortar specimen.

The suitability of binder systems comprising BanahCEM and GGBS was confirmed via XRD analysis of BanahCEM-60% GGBS (this high replacement level being chosen to represent a worst case scenario) powder samples and corresponding geopolymerised pastes prepared at a liquid:solids ratio of 0.264. From Figure 2(d) it can be seen that the amorphous aluminosilica hump between 20-30 2θ identified for the powder sample became more pronounced for the ground paste sample, confirming the presence of additional aluminosilicate gel phases associated with geopolymerisation. Crystalline peaks noted for both sample types can be traced back to the original lithomargic clay-derived metakaolin and correspond with hematite, a form of crystalline iron oxide formed when goethite and magnetite from the raw lithomarge is calcined (Fernandez-Jimenez et al, 2013). For the BanahCEM/70% GGBS paste sample, two new peaks are apparent at 26.6 and 29.4 2θ , which from previous research can be linked to calcium

Flow, setting time (initial and final) and compressive strength (3 hrs, 1, 7 and 28 days) results for the GGBS-based mixes considered in Phase 2 are reported in Figure 2(a and b) relative to the performance of control mix 6 (i.e. no GGBS). Clearly from Figure 2(a), the addition of GGBS had a marked influence on fresh mortar properties, with flow levels increasing by 9-15% as the GGBS replacement level increased from 40-60% by mass. Classed as 'plastic mortars' (BSI, 1999), these flow results confirmed levels of workability suitable for small-scale repair applications. A more significant influence of GGBS is apparent from Figure 2(a) in relation to mortar setting times, where GGBS replacement resulted in initial and final setting times on average 85% lower than the non-GGBS control. With final setting times of 30 minutes recorded for all GGBS mixes, this aligns well with the requirement given in Specification for Highway Works clause 946 (2005) for pothole repair materials to have sufficiently hardened to be capable of trafficking without damage after 30 minutes. In terms of compressive strength, Figure 2(b) clearly shows how the GGBS-based mixes obtained significantly higher strengths relative to the control at 3 hours. At 3 hours mix 6 had just achieved final set and yielded a relatively low compressive strength result of 13.3 MPa (17% of its 28-day value). In contrast, all GGBS-based mixes achieved values in the range 31-34 MPa (on average 150% higher than the control mix and 40% of their 28-day values). At 24 hours, a similar but less pronounced trend was apparent (GGBS mixes achieving values in the 53-54 MPa range in comparison to 39 MPa for the control). Conversely after 7 and 28 days, a state of performance equivalence was achieved, with the control mix marginally out-performing mixes 6-40 and 6-50%. Only mix 6-60% out-performed the control in terms of compressive strength at all test ages.

The positive influence of GGBS on mortar performance was confirmed to be as a result of additional available calcium and silicates in the geopolymer cement matrices (Figure 2(c)). Plotted in this figure are quantities of calcium and silicates within each sample as determined using the salicylic acid/methanol extraction method in relation to both 3-hour compressive strength and initial setting time. Clearly, the level of calcium and silicate impacts both properties significantly, with increasing calcium and silicates content resulting in reduced setting times and increased strength levels; an affect reported to occur due to increased dissolution rates of geopolymer phases causing reactions to occur more rapidly (Hunnicut, W.A., 2013). This work reinforces the potential suitability of GGBS-based geopolymer as a rapid repair highway solution.

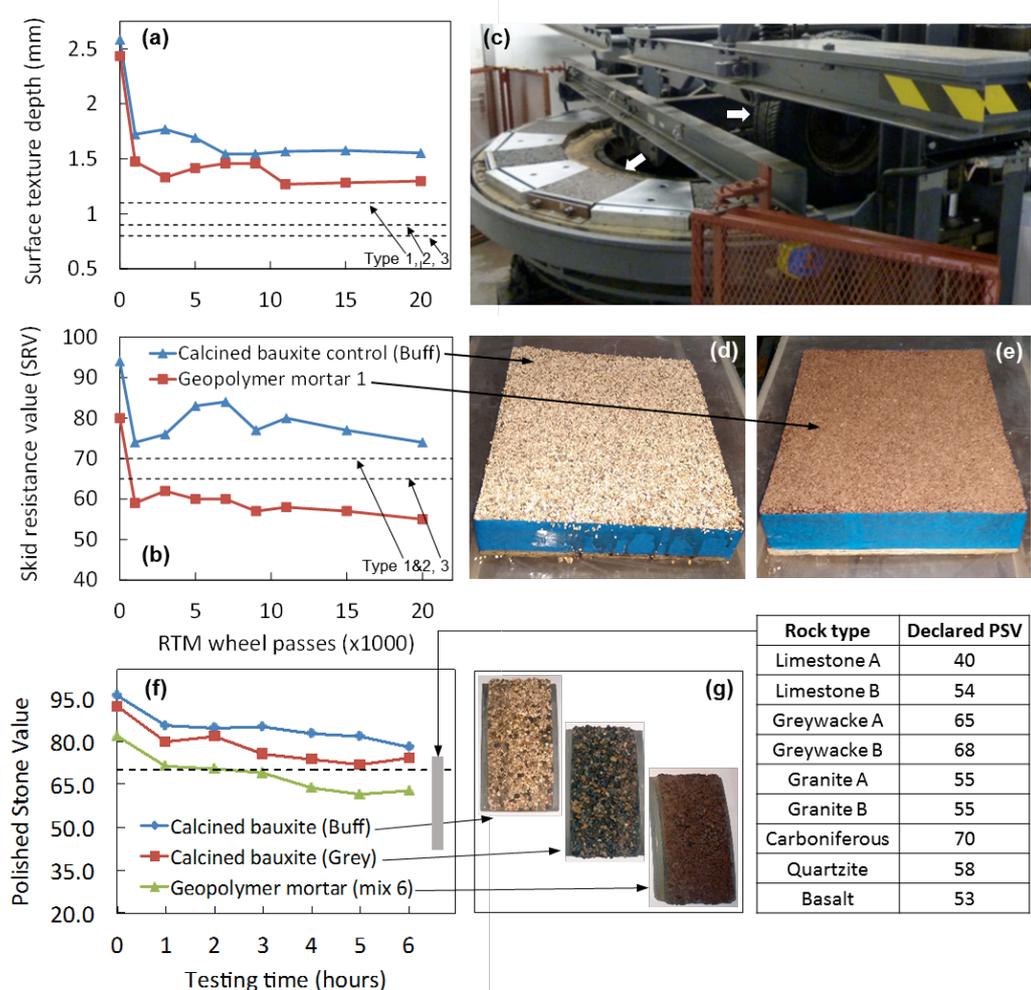
Figure 3. (a & b) Relationships between number of accelerated road test machine wheel passes and texture depth and skid resistance value; (c) Experimental test set up of Ulster University's accelerated Road Test Machine (locations of test specimens and tyres highlighted); (d & e) Images of test specimens prepared using calcined bauxite and geopolymer cement mortar-based high friction aggregates; (f) Relationships between polished stone value and testing time for calcined bauxite and geopolymer cement mortar-based aggregate samples (including published values for natural aggregates (Woodward and Friel, 2017)); and (g) Images of test specimens for polished stone value testing.

In terms of skid resistance, average values of 41 and 39 were recorded after simulated wear testing for mix 6 and mix 6-60% specimens respectively. While these values represented negligible decreases during testing, these performance level fall short of the minimum required values of 45, 55 and 65 prescribed in RRL Road Note 27 (1969) for: public roads; trunk roads and motorways; and bends and roundabouts, respectively. This finding is not surprising, however, given the lack of surface texturing applied to the patch repairs in this preliminary testing stage. To fully develop solutions suitable for road pavement exposure, ongoing research in this area is focused on geopolymer cement mortar patches with applied surface textures, installed in pothole recesses with vertically cut and cleaned edges, and subjected to 100,000 ± 1000 wheel passes.

Geopolymer cement mortar-based aggregates were produced using material recycled from mix 6 specimens used for compressive and flexural strength testing in Phase 2. After mechanical testing, specimens were reduced in size using a jaw crusher and the resulting material sieved in accordance with BS EN 1015-1 (1999) to retain aggregates in the 1-3 mm range. Commercially available calcined bauxite aggregates in the same size range were used as controls. Testing apparatus and example test specimens used for simulated road surface wearing and PSV testing are shown in Figure 3(c, d and e).

respectively) decreased significantly after 1,000 wheel-passes, with performance levels largely stabilizing thereafter up to 20,000 wheel passes (Figure 3(a & b)). Average texture depth values for the calcined bauxite control and geopolymer mortar specimens decreased from 1.72 to 1.55 mm (9.9% decrease) and from 1.47 to 1.29 mm (12% decrease) respectively between 1,000 and 20,000 wheel passes. With both of these final values exceeding the minimum road surface requirement of 1.1 mm (DMRB, 2006), albeit that this limit relates to 100,000 wheel passes, these provisional findings suggest suitably high levels of geopolymer mortar durability under traffic loading.

To investigate relative skidding resistance behavior more comprehensively, modified PSV testing was undertaken using standard test specimens (Figure 3(g)) to assess the performance characteristics of each aggregate type and their polishing susceptibility under traffic loading. Similar to trends noted for SRV, initial average PSV values recorded for geopolymer aggregate was appreciably lower than for the bauxite controls (82 compared to 94) (Figure 3(f)). While decreases in performance thereafter up to six hours of testing were similar for both aggregate types (22 and 19% respectively), the initial disparity was reflected in the ultimate average performance levels recorded (76 and 63 respectively). While geopolymer aggregates fell short of the '68+' classification given in DMRB HD36/06 [2006] for high performance materials, when benchmarked against declared PSV values for hard wearing natural aggregates and years of related research into this field (Woodward and Friel, 2017), it is clear that the prototype geopolymer aggregates assessed show excellent potential for application in this field.
