Development of resilient and environmentally responsible highway infrastructure solutions using geopolymers cement concrete

Allistair Wilkinson¹, Bryan Magee¹, David Woodward¹, Svetlana Tretsiakova-McNally²

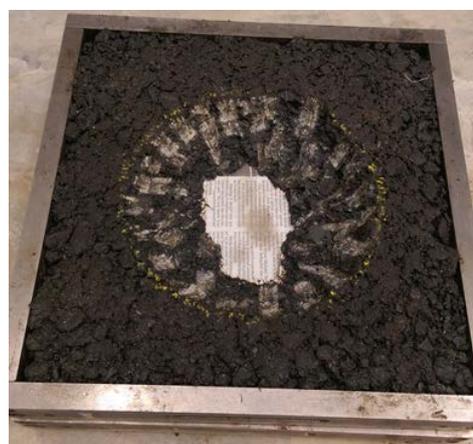
An asphalt slab, with dimensions of 275 x 275 x 40 mm, was produced. Using a hammer and chisel, material was manually removed to form a circular defect with irregular sloped sides, and an approximate volume of 0.001m³ (Figure 1). The irregular shape of the defect meant that the conditions in which the geopolymer mortar would have to bond to the asphalt were poor, meaning that there was a risk of the mortar popping out of the specimen. This provided a worst case scenario for which the geopolymer mortar may have to endure. The high strength geopolymer mortar was placed in the defect and compacted using a steel tamping rod, followed by 30 seconds on a compacting table. Excess material was removed using a hand trowel. No additional surface texturing was applied to the geopolymer mortar. The slab was wrapped in a polythene bag for 24 hours for moisture retention. After 24 hours, the polythene was removed, and the slab was store at an ambient temperature of 20 ± 2 °C for 6 days prior to testing.

Figure 1. Simulated pothole for geopolymer repair material investigation.

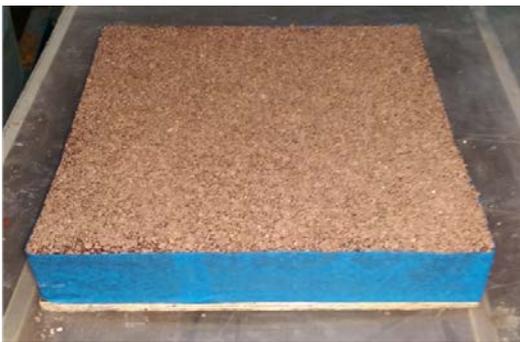
The geopolymer high friction aggregate was produced using waste geopolymer mortar specimens from the initial geopolymer strength testing studies. After the specimens were tested for compressive and flexural strength, the mortar was crushed using a jaw crusher. This formed a recycled geopolymer mortar aggregate. The material was sieved, according to BS EN 1015-1: 1999 [13] to retain particles sized from 1 to 3 mm. A 1:1 ratio of two part epoxy resin was mixed, and a 2 mm layer applied to a 10 mm stone mastic asphalt (SMA) slab measuring 300 x 300 x 50 mm. The geopolymer aggregate was dispersed over the slab until the epoxy had been covered. After allowing the epoxy resin to cure for 24 hours, excess aggregate was removed using a wire brush. Figure 2 shows the geopolymer high friction surface slab, prior to testing. This production method was then repeated with a second 10 mm SMA slab, using conventional calcined bauxite aggregate with the epoxy resin binder. This slab was tested alongside the geopolymer slab as a control sample to provide a benchmark for the initial geopolymer aggregate investigation.

Figure 2. Crushed geopolymer mortar high friction surface test specimen.

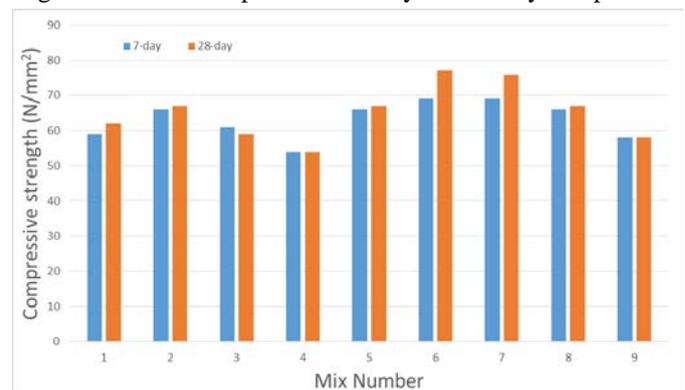
Figure 3. Relationship between 7 day and 28 day compressive

strengths of geopolymer mortar mixes.

Table 2 shows the mean 7 day compressive strengths, and mean 28 day compressive and flexural strengths. As shown in the results, all specimens exhibited 7 day compressive strengths of at least 89% of the 28 day compressive strengths. Mixes 4 and 9 achieved the 28 day strength after 7 days, while mix 3 showed a slight reduction in compressive strength of around 3%, between 7 days and 28 days. As mix 3 had a higher activator content than the other mixes, this may suggest that the activator content exceeded the maximum content level of this component. Figure 3 illustrates the relationship between 7 day and 28 day compressive strengths. It was also found that the majority of 28 day flexural strength results were around 4% of the corresponding 28 day compressive strengths. This is a common trend when testing mortars using only fine aggregate. However, no trend between 28 day compressive strength and 28 day flexural strength was obvious from this investigation.

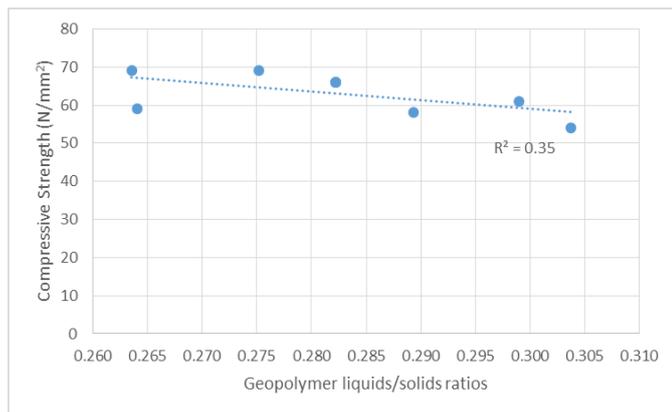
Figure 4. Effect of geopolymer liquids to geopolymer solids ratio on the 7 day compressive strength of geopolymer mortar.

The ratio of geopolymer binder liquids to geopolymer binder solids is thought to play a role in the compressive strength of geopolymer mortar, much like the effect of water/cement ratio when using ordinary Portland cement. Figures 4 and 5 show the effect of geopolymer liquids to solids, for 7 day and 28 day compressive strengths respectively. As shown in figure 4, after 7 days, the general trend is that compressive strength decreases, as the geopolymer liquids to solids ratio increases ($R^2=0.35$). Figure 5 shows that this relationship becomes more apparent for 28 day compressive strength ($R^2=0.54$).

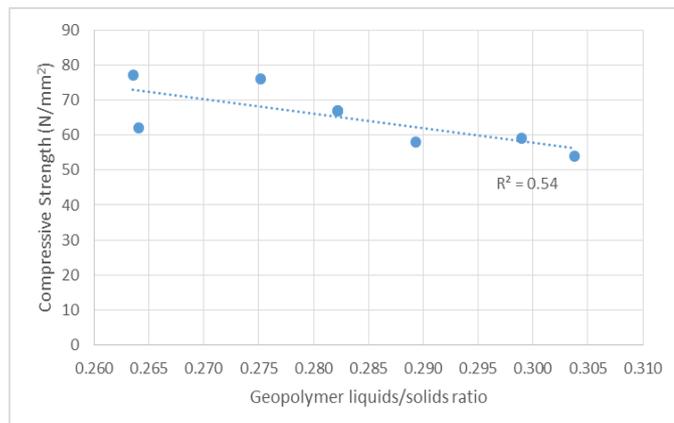
Figure 5. Effect of geopolymer liquids to geopolymer solids ratio on the 28 day compressive strength of geopolymer mortar.

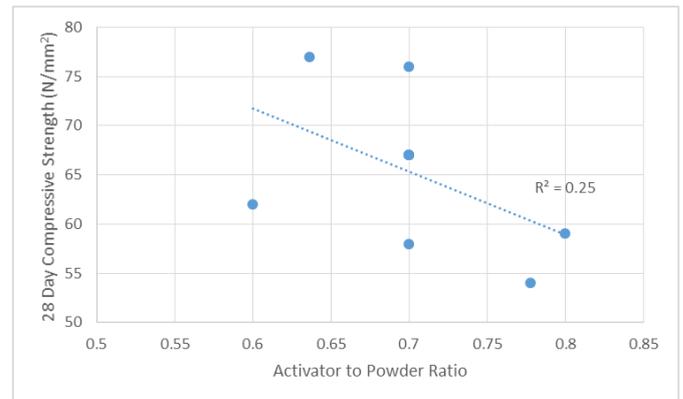
Figure 6. Effect of activator to powder ratio on 28 day compressive strength of geopolymer mortar.

The ratio of activator to powder also appears to play some role in the 28 day compressive strength of geopolymer mortar. This trend is shown in Figure 6, where $R^2=0.25$. However, some variance in the results would indicate that the geopolymer liquid to solids ratio plays a more important role in the geopolymer strength development.

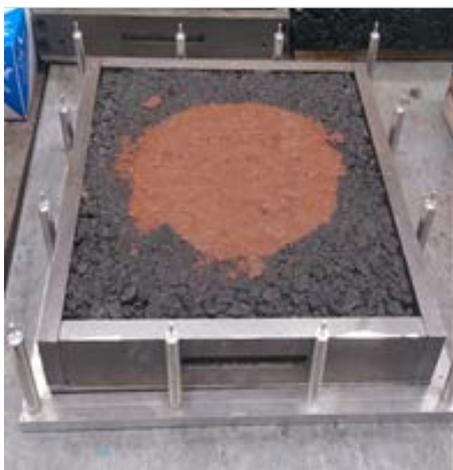
Figure 7. Geopolymer pothole repair material after simulated wearing.

After 20,000 wheel-passes, a visual assessment of the specimen was carried out. As geopolymer mortar is an untested material in this application, using this test method, it was expected that some performance issues would occur during the initial testing. Concerns about potential failure were due to the stiffness of hardened geopolymer cement mortar, and the possibility of the geopolymer mortar being incompatible with the existing asphalt surrounding the defect. However, after 2000 wheel passes, no surface defects were noticed (Figure 7). The visual assessment focused on surface cracking, delamination, de-bonding of the geopolymer from the asphalt, and material loss. The only indication of wear was some shining of the material surface. The skid resistance was measured before and after the accelerated wearing of the sample. The skid resistance decreased slightly from 43 to 41

after wearing. While this was a positive initial test, the performance falls short of the requirements set out by RRL Road Note 27 [15]. The minimum skid resistance value for materials used on public roads is 45, with trunk roads and motorways requiring 55, and bends and roundabouts requiring 65. Therefore, further work involving surface texturing will be required to develop a geopolymer mortar which is suitable for road pavement use. Also, it is suggested that samples should be subjected to $100,000 \pm 1000$ wheel passes [14]. While initial durability results appear positive, a more extensive testing programme will be required to determine the performance of the repair material after much greater exposure to wearing conditions.

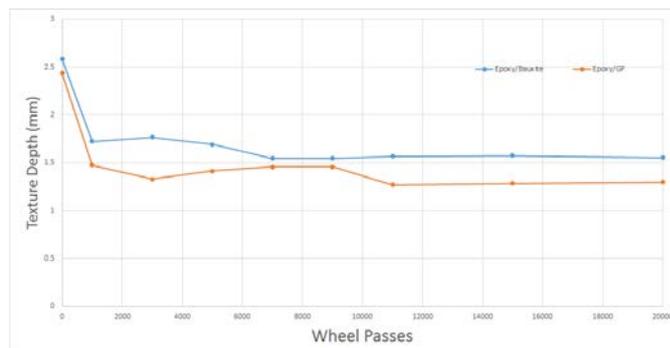
Figure 8. Effect of simulated wearing on surface texture depth.

The high friction surface slabs were subjected to 20,000 wheel passes, with texture depth and skid resistance measured prior to testing, and at various intervals during testing. Prior to testing, the texture depth of the geopolymer aggregate sample was recorded as 2.43 mm, with a skid resistance value of 80. The control slab had an initial texture depth of 2.58 mm, and a skid resistance value of 94. Figure 8 shows the changes in texture depth during testing. Figure 9 shows the changes in skid resistance during testing. After 20,000 wheel passes, the geopolymer slab retained a texture depth of 1.3 mm, and a skid resistance value of 55. This represented a 47% decrease in texture depth and a 31% decrease in skid resistance. This is compared with the calcined bauxite, which has a retained texture depth of 1.55 mm (40% texture loss) and a skid resistance value of 74 (21% skid resistance loss). Both slabs showed a significant decrease in texture depth after 1000 wheel passes. The geopolymer aggregate texture depth reduced by 39% after 1000 wheel passes, and the calcined bauxite texture depth reduced by 33%. After the initial 1000 wheel passes, the texture depth loss of the samples was more stable. While the retained texture depth of the geopolymer aggregate slab was significantly lower than the initial value, the 1.3 mm texture depth exceeds the minimum requirements for a road surface. The reference slab had a retained texture depth of 1.6 mm.

From the results, the skid resistance value differences between the samples may be attributed broadly to a difference in macrotexture depths. However, the results show that a decreasing texture depth doesn't directly compare with decreasing skid resistance values. This may suggest that factors other than macrotexture, such as aggregate shape and size may also have an effect on the skid resistance of a high friction surface. Also, some unexpected texture depth readings, such as the increase in geopolymer slab texture depth between 11,000 and 20,000 wheel passes, may be attributed to some aggregate being removed during testing. Further work is required in this area to better understand the factors which affect the skid resistance of high friction surfaces.

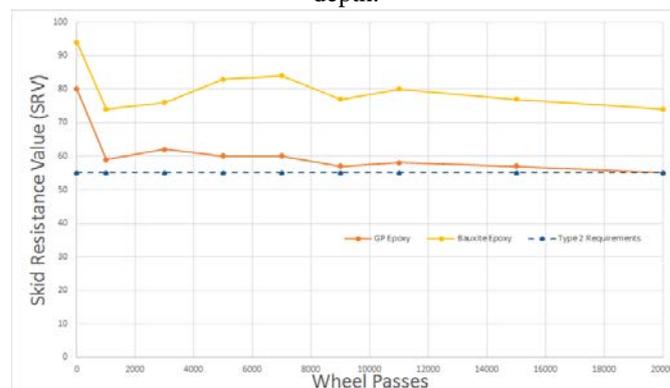
Figure 9. Effect of simulated wearing on skid resistance values.

The skid resistance value of the geopolymer aggregate slab can be classified as a Type 2 surface, according to RRL Road Note 27 [15], while the calcined bauxite slab achieved a Type 1 classification, as expected. This means that the geopolymer aggregate, without any further work or development, would be suitable for use in a type 2 application, such as trunk roads or motorways.
