The Structural Behaviour of Lightweight Composite Trusses in Fire during The Event of World Trade Centre

SENG-KWAN CHOI¹, IAN BURGESS^{1*} AND ROGER PLANK²

ABSTRACT: On September 11 2001, the twin towers of World Trade Centre were struck by two hijacked airplanes. Despite severe local damage induced by the impact, the towers were able to sustain 103 and 56 minutes of the subsequent fire. The purpose of this study is to contribute to the understanding of the behaviour of WTC 1 tower, during the events, in structural fire engineering terms. Using FE package VULCAN, the structural mechanism of the typical long-span composite floor trusses in fire is explained under a variety of scenarios, varying boundary condition, degree of protection and loading. The results are presented as graphs of deflections against time.

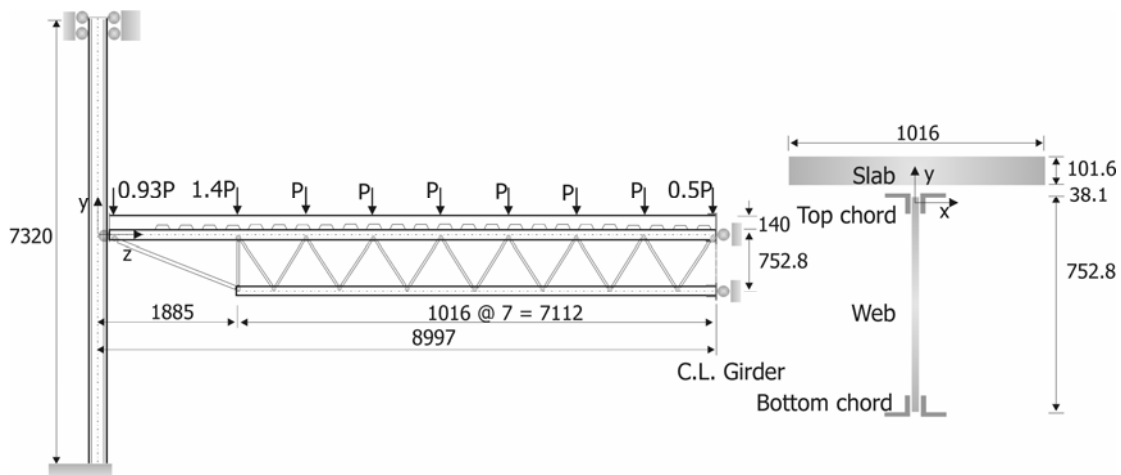
For this study, a symmetric half of the composite truss was numerically modelled with and without a supporting column (Fig 1). In the case of the composite truss, which includes the column, a pinned beam-to-column connection was inserted. For the isolated truss case, a simple support was used as the end boundary condition. The connection between the bottom chord and the external column was ignored due to the fact that there was no application of fire protection to the part. The proposed model was designed assuming continuous bottom chord & top chord with the LWC slab excluding the steel decking. The pin-ended webs are connected between the centroid of the top and bottom chords. No eccentricity was regarded at the connections. The geometry was assumed to be such that no local damage was induced due to the collision of the airplane.

Figure 1 Layout of the composite truss (dimensions in mm)

In the long span area, which is the immediate area of impact in WTC 1, a dual composite truss, 18.3m length, 2.0m spacing and 752.8mm depth, with a concrete slab and profiled metal decking was used. The vertical floor-to-floor spacing was 3.7m. Double angles of L 50.8mm \times 38.1mm \times 6.4mm (A50) and L 76.2mm \times 50.8mm \times 9.4mm (A36) were selected for the top and bottom chords. A solid round bar of $\phi 29.0\text{mm}$ (A50) was used for the first web member. The remaining webs comprised a solid round bar of $\phi 27.7\text{mm}$ (A46). The steel decking was placed underneath the lightweight concrete ($20.7\text{N}/\text{mm}^2$) of 101.3mm topping and 38.1mm rib. The top chord, locally stiffened, was connected to the external and core columns by means of a steel angle (coupled using two 15.9mm bolts), with a welded

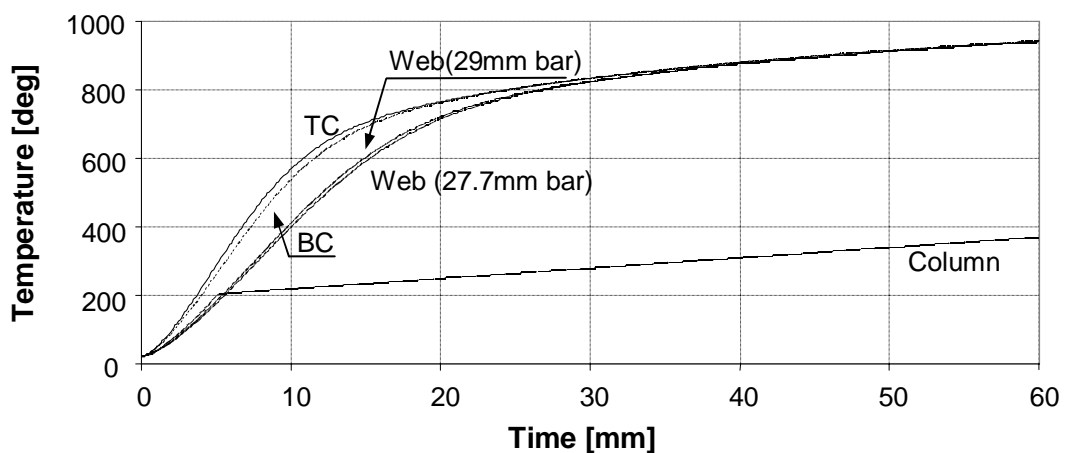
In the unprotected case, the temperature development of each of the chords (Fig 2) was calculated upon the section factor, A/V , using a formula provided by Eurocode4: Pt1.2 [9]. The temperature increase, $\Delta\theta_a$, of unprotected steel chords during the time interval, Δt , may be determined by following formula:

Figure 2 Temperature development of unprotected chord members in the standard fire

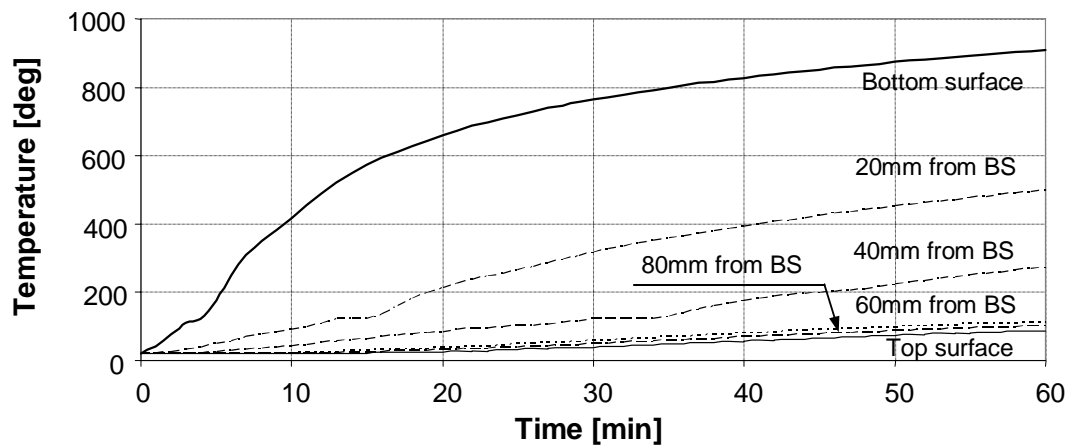
A thermal analysis (Fig 3) was conducted, using heat transfer software [10], to generate the temperature development of the LWC slab topping, divided into 9 layers with the steel decking, in the standard fire. The moisture content was taken to be 2% of the concrete weight and coefficients of heat transfer were chosen from generic data given by Purkiss [11].

Figure 3 Temperature development of 100mm topping of LWC slab in the standard fire

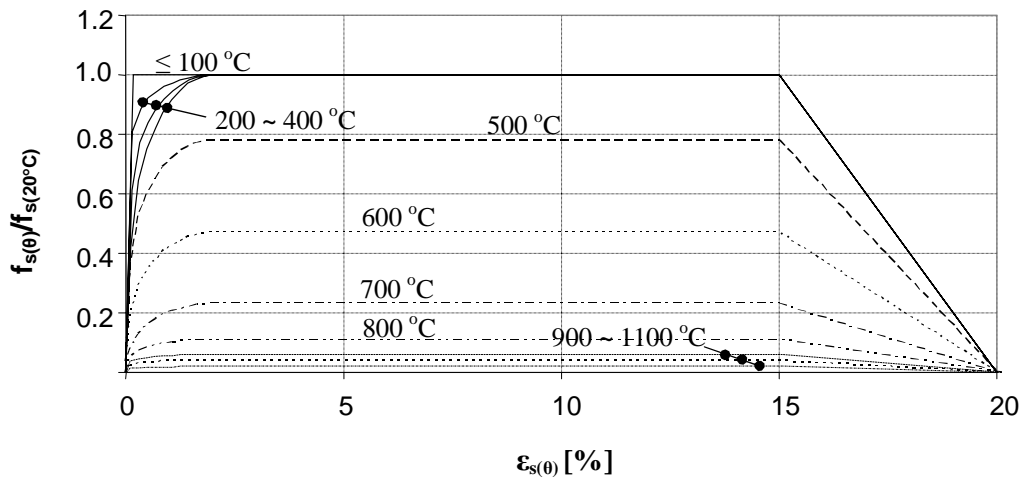
The stress-strain relationship of the steel, at elevated temperatures, is determined, as shown in Figure 4. A set of linear-elliptical curves, excluding a strain hardening, illustrates that the yielding initiates from 2% strain limit at any temperature and the ultimate strain is defined at 20% strain limit. It is assumed to be identical under both of the stress condition, compression and tension. The constitutive model contains the unloading path, including the plastic strain. It is noted that the steel begins to lose significant amount of the strength, of 2% strain limit, at temperature above 400°C and approximately 11% of the strength remains at 800°C. It defines the yield stress to be zero at 1200°C for design purposes.

Figure 4 Stress-strain relationship of steel at elevated temperatures

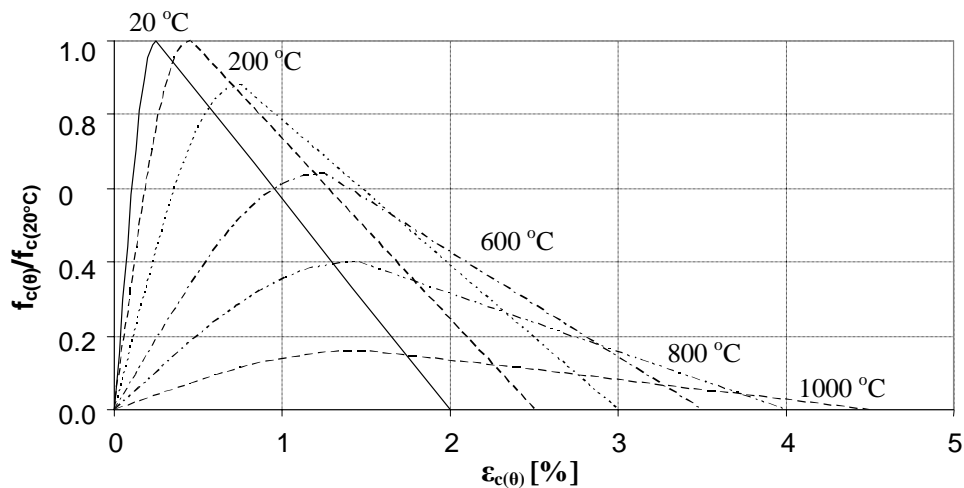
Due to the heterogeneous nature of concrete, such as a mixture of cement paste, mortar, aggregate, small quantities of additions, various forms of water and pores, it is difficult to establish accurate temperature-dependent characteristics. The stress-strain relationship of light-weight concrete in compression at elevated temperatures, used for this study, is shown in Figure 5. The light-weight concrete has lower decrease of strength and stiffness at elevated temperatures, due to the low thermal conductivity of lightweight aggregate compared to normal concrete [13]. The tensile strength of the concrete at elevated temperatures is taken into account by adapting a tensile stress-strain curve, proposed by Rots et al.[14] and tested by Hunag[15] & Jun[16]. The curve, as shown Figure 6, is modelled to have an linear behaviour to the peak tensile strength, $f_t(\theta)=0.3321\sqrt{f_c(\theta)}$ [17], which does not exceed 10% of corresponding compressive stress suggested by Eurocode4:Pt1.2 [9]. Then, a bilinear curve for tensile strain-softening after cracking [18], upto the maximum tensile strain, $\epsilon_{ct}(\theta)=15f_t(\theta)/E_c(\theta)$. After cracking under tension, the concrete is still able to carry compression, but when crushing under compression, it is ignored.

Figure 5 Stress-strain relationship of concrete in compression at elevated temperatures

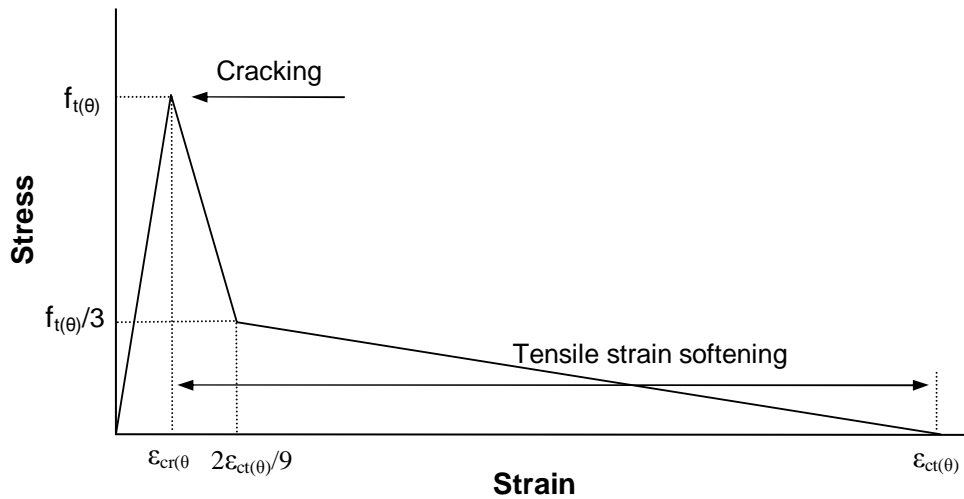
Figure 6 Stress-strain relationship of concrete in tension at elevated temperatures

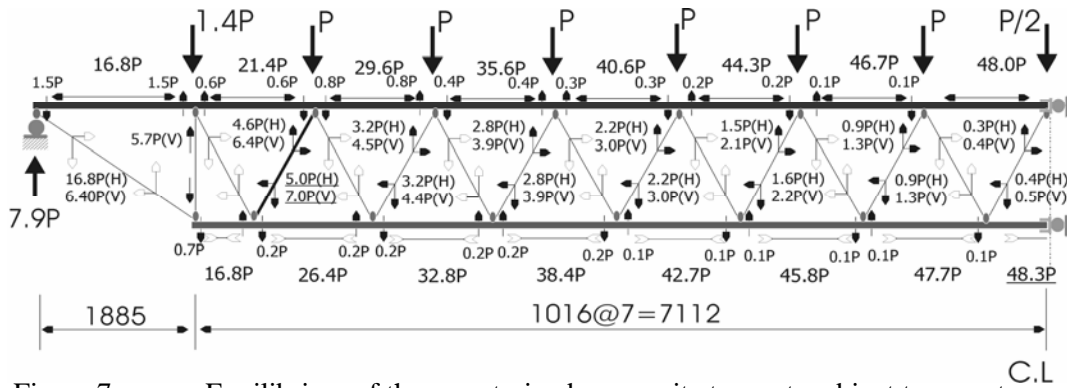
The equilibrium condition of the composite truss at ambient temperature is illustrated in Figure 7. Double black and white arrows indicate compression and tension respectively. Single black vertical arrows represent resultant shear forces. The critical elements of the

model can be identified at ambient temperature by examining the load ratios in the members. The peak value of load ratio under tension occurs in the mid-span member of the bottom chord, 8.5-9.0m from the support. For compression it is the second compressive web, which is the fourth web member from the support.

Figure 7 Equilibrium of the unrestrained composite truss at ambient temperature

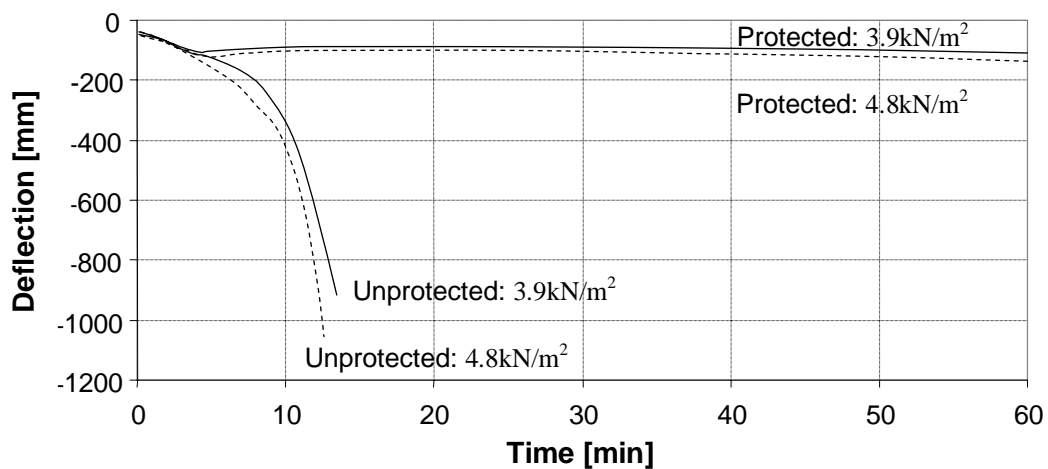
The numerical analyses of the protected and unprotected composite truss are shown as a vertical deflection against time in Figure 8. The protected composite truss, under the loadings, 4.8kN/m^2 and 3.9kN/m^2 , deflects approximately $L/100$ and $L/150$ at 60 minutes of the standard fire. During the period, the flexural mechanism of the protected model is maintained without any local instability. The unprotected trusses resist up to 12.5 and 13.4 minutes, at which time the second compressive web buckles due to the rapid temperature increment of the unprotected webs at early stage of the resistance period. The local instability initiates the failure of the flexural mechanism of the model. Hence, the protection condition of critical web elements is the sensitive factor under the considered level of the loads, in terms of the structural resistance in the standard fire regarding simply-supported models. The unprotected condition can represent any kind of the structural damage in this case. Details of a similar pattern in the structural mechanism of a composite truss in fire were shown for more general configuration of the composite trusses [25].

Figure 8 Vertical deflection of the mid-span of the top chord in the standard fire

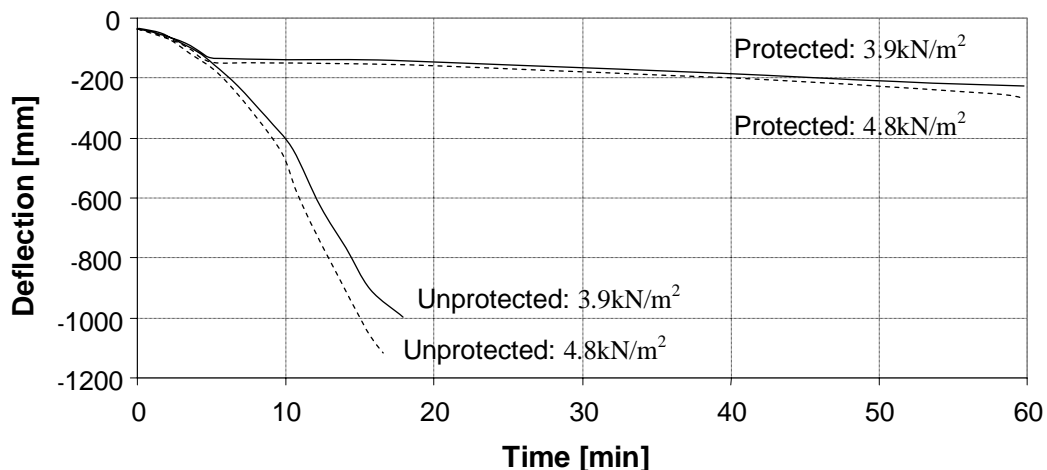
Figure 9 shows that the protected models resist 60 minutes of the standard fire with deflection of about $L/90$. During this period, the flexural mechanism was maintained (Fig. 11(a)) as that of unrestrained condition. Hence, the column consistently experiences a push-out force (Fig. 10) due to the thermal elongation of the slab and top chord.

Figure 9 Vertical deflection at the mid-span of the top chord in the standard fire.

The unprotected models under 4.8kN/m^2 and 3.9kN/m^2 are shown in Figure 9 to have their first local instability at 16.1 and 18.0 minutes of the standard fire. The second compressive web, which was demonstrated to contain the highest compressive load-ratio in the simply supported condition, was the first to buckle (Fig. 11(b)). Through a load redistribution process, the compressive web with the next highest load-ratio was observed to buckle progressively at the same time. Eventually, the series of progressive local instabilities caused the remaining part of the composite truss to collapse via tension of the slab and top chord (Fig. 11(c)). Regarding the reaction of the beam-column connection, it can be seen in Figure 10 that the horizontal reaction changed from outward to inward direction at 11.7 minutes of the standard fire. This occurred because the flexural capacity of the composite truss reduces significantly due to the temperature increase of the unprotected bottom chord. It can be noticed that, at 11.7 minutes, the temperature of the member reaches approximately 600 degrees, at which the strength retention of 2% strain limit for tension members is 42% [12]. Afterward, the yielding starts in a spreading motion from the mid-span to the remaining

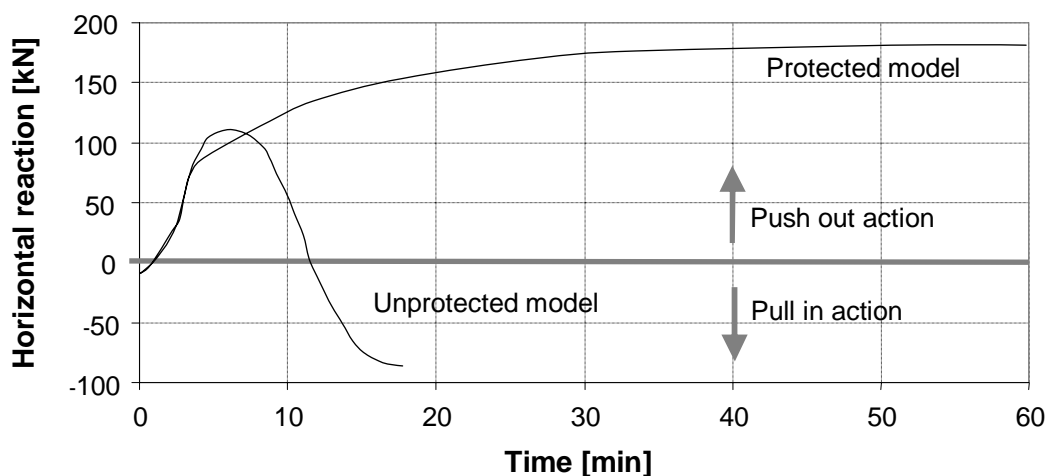
To simulate the top and bottom floors in the fire-exposed levels or floors in localized compartment fire, the structural behaviour of protected and unprotected composite trusses with a supporting column, for 60 minutes of the standard fire, was numerically investigated using VULCAN under both of the loadings, 4.8kN/m^2 and 3.9kN/m^2 . The performance of the models is shown, in Figure 9, in terms of the vertical deflection of the mid-span top chord against time. In order to present the contribution of the supporting column to the behaviour of the composite truss in fire, the variation of the horizontal reaction at the beam-column connection, under the arbitrary loading, is plotted in Figure 10.

Figure 10 Horizontal reaction at the beam-column connection under estimated loading in the standard fire.

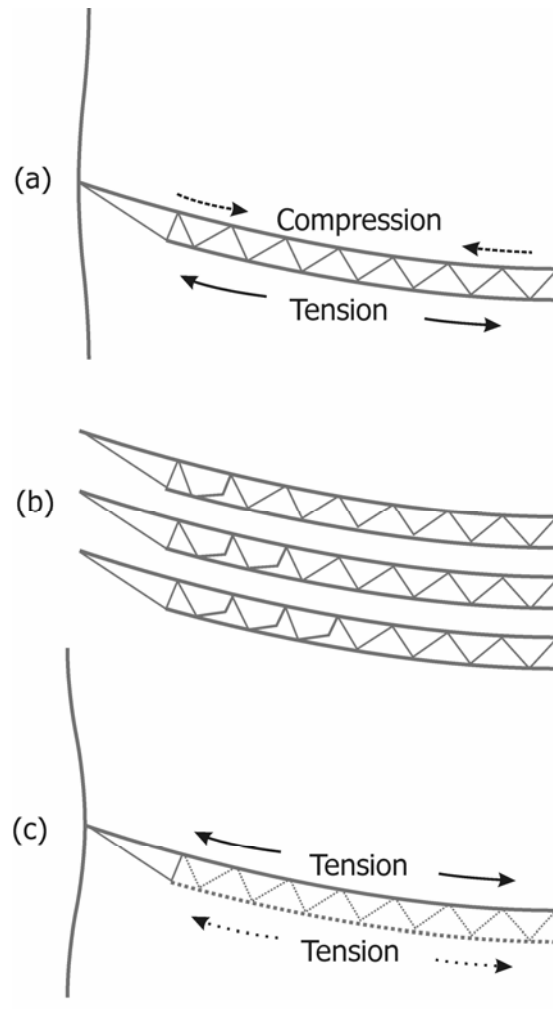
Figure 11 Structural mechanism of the composite truss in fire: (a) in bending; (b) as diagonals buckle; (c) in full catenary action

members in the bottom chord. Once this condition occurs, the moment resistance of the composite truss, generated by the lever arm between top and bottom chords, ceases to be valid. Therefore, the mechanism of the composite truss is transformed such that the slab and top chord to carry the imposed load in tension rather (Fig. 11(c)) than compression (Fig. 11(a)). This phenomenon is called 'catenary action'. The structural advantage, generated by the catenary action of the composite truss with respect to the fire resistance, might not be fully utilized in this unprotected model due to the simultaneous local instabilities.
